# A LITTLE ROOM FOR THE RIVER PLEASE !!!

## The case of Prairie Creek in Lebanon, Boone County, Indiana

INAFSM 2017 Annual Conference

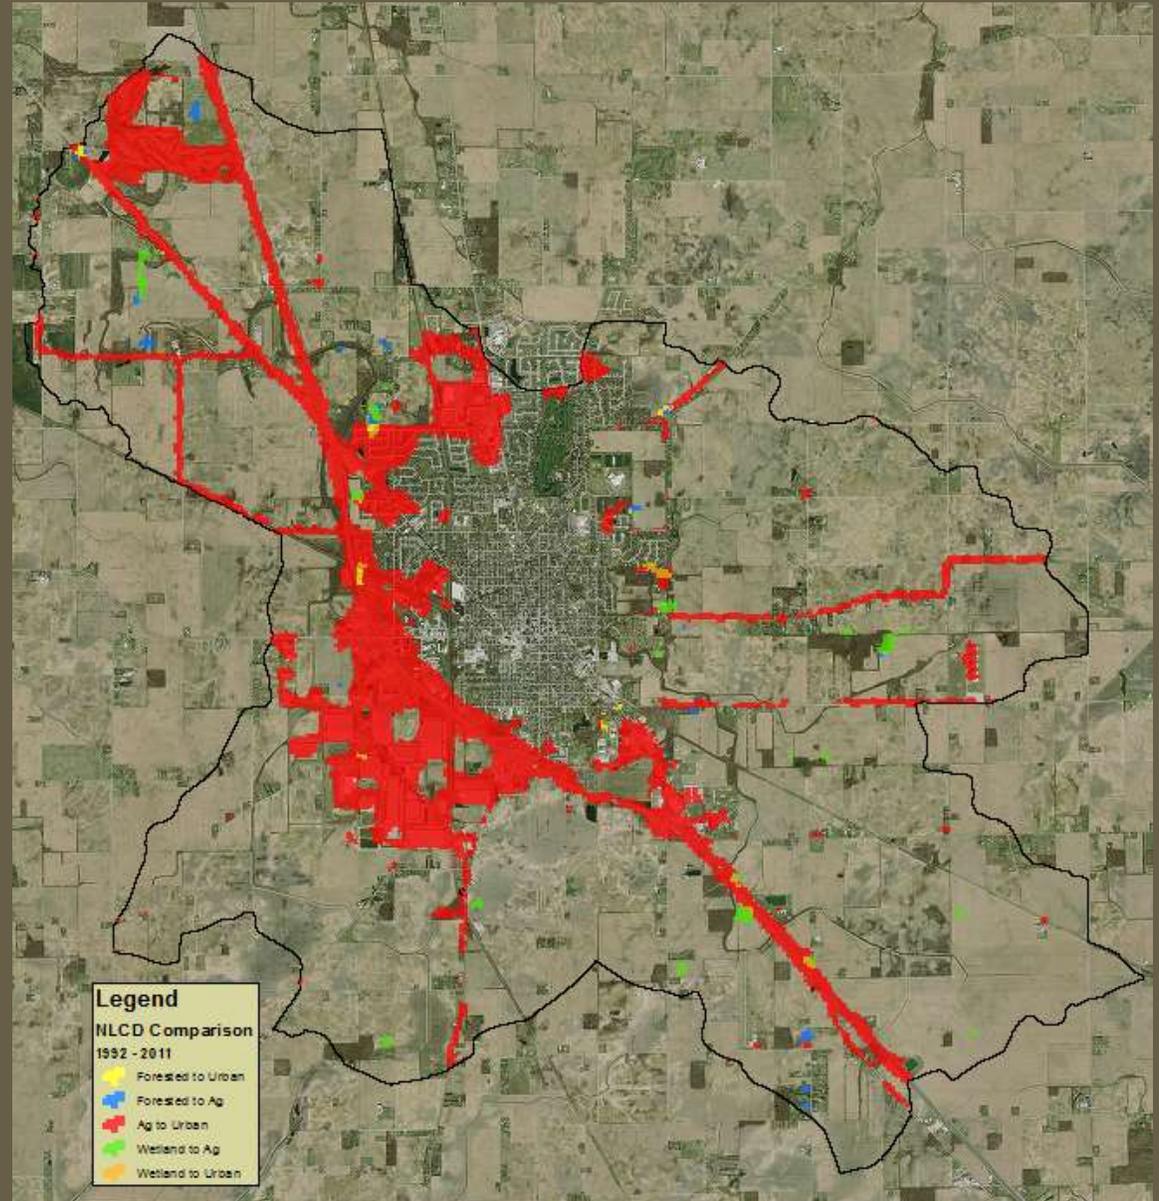
- Percentage of urban areas in the watershed doubled from 1992 to 2011
- Most of the growth in Sanitary Ditch watershed
- Prairie Creek watershed also seeing significant urbanization near Lebanon
- More urban area = more impervious area = more and faster runoff = more erosion

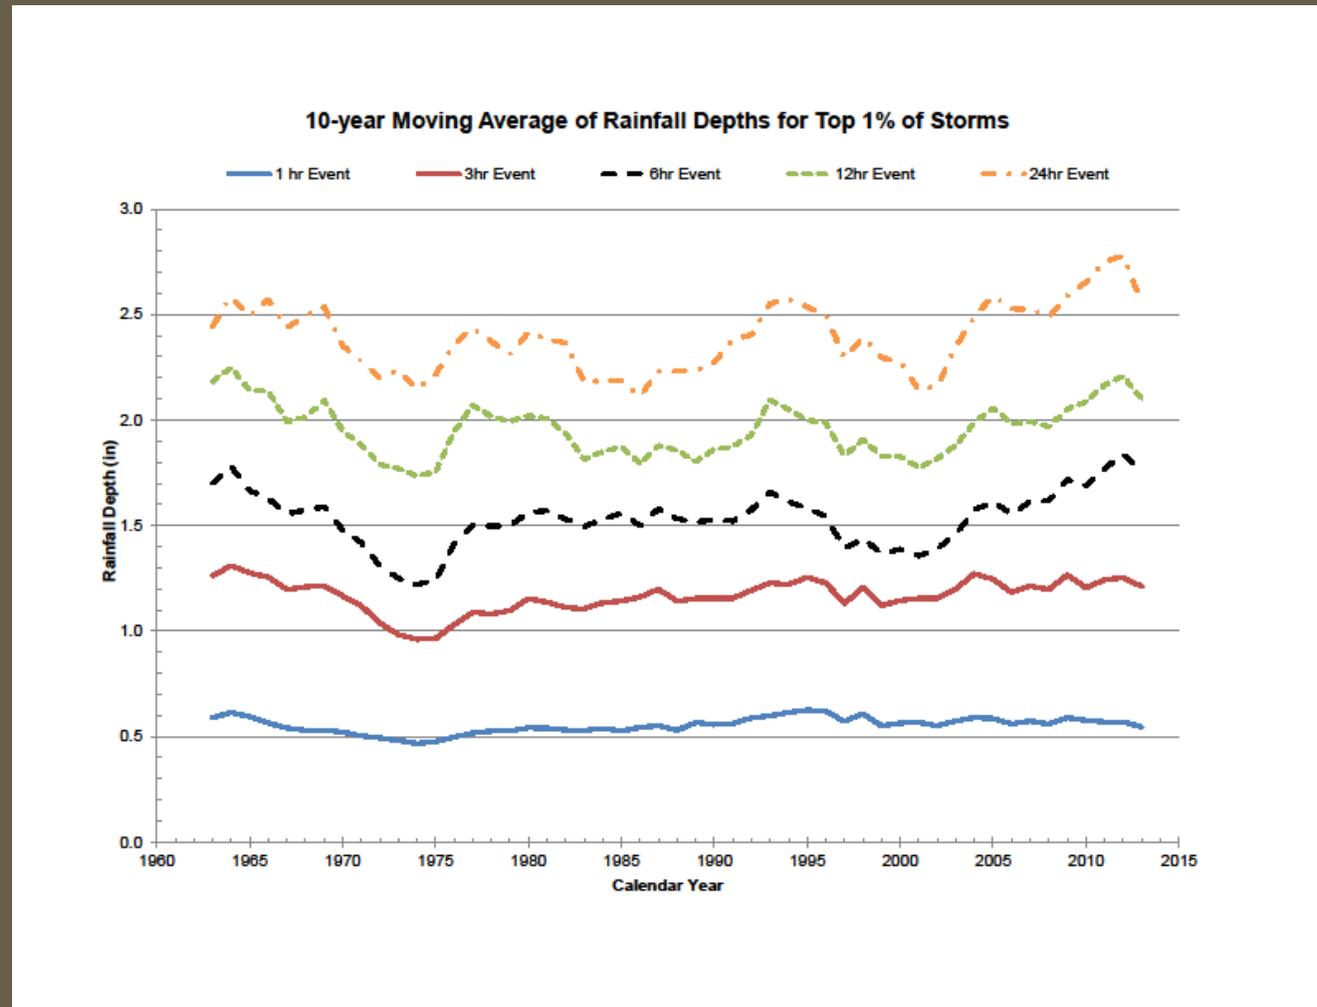
- Significant increase in heavy precipitation, especially for the 24-hour duration, since 1970s
- More intense and larger heavy rainfall = more and faster runoff = more erosion

Rainfall Depth Exceeded by Top 1% of Events by Duration (10-year Moving Average) at Indianapolis International Airport

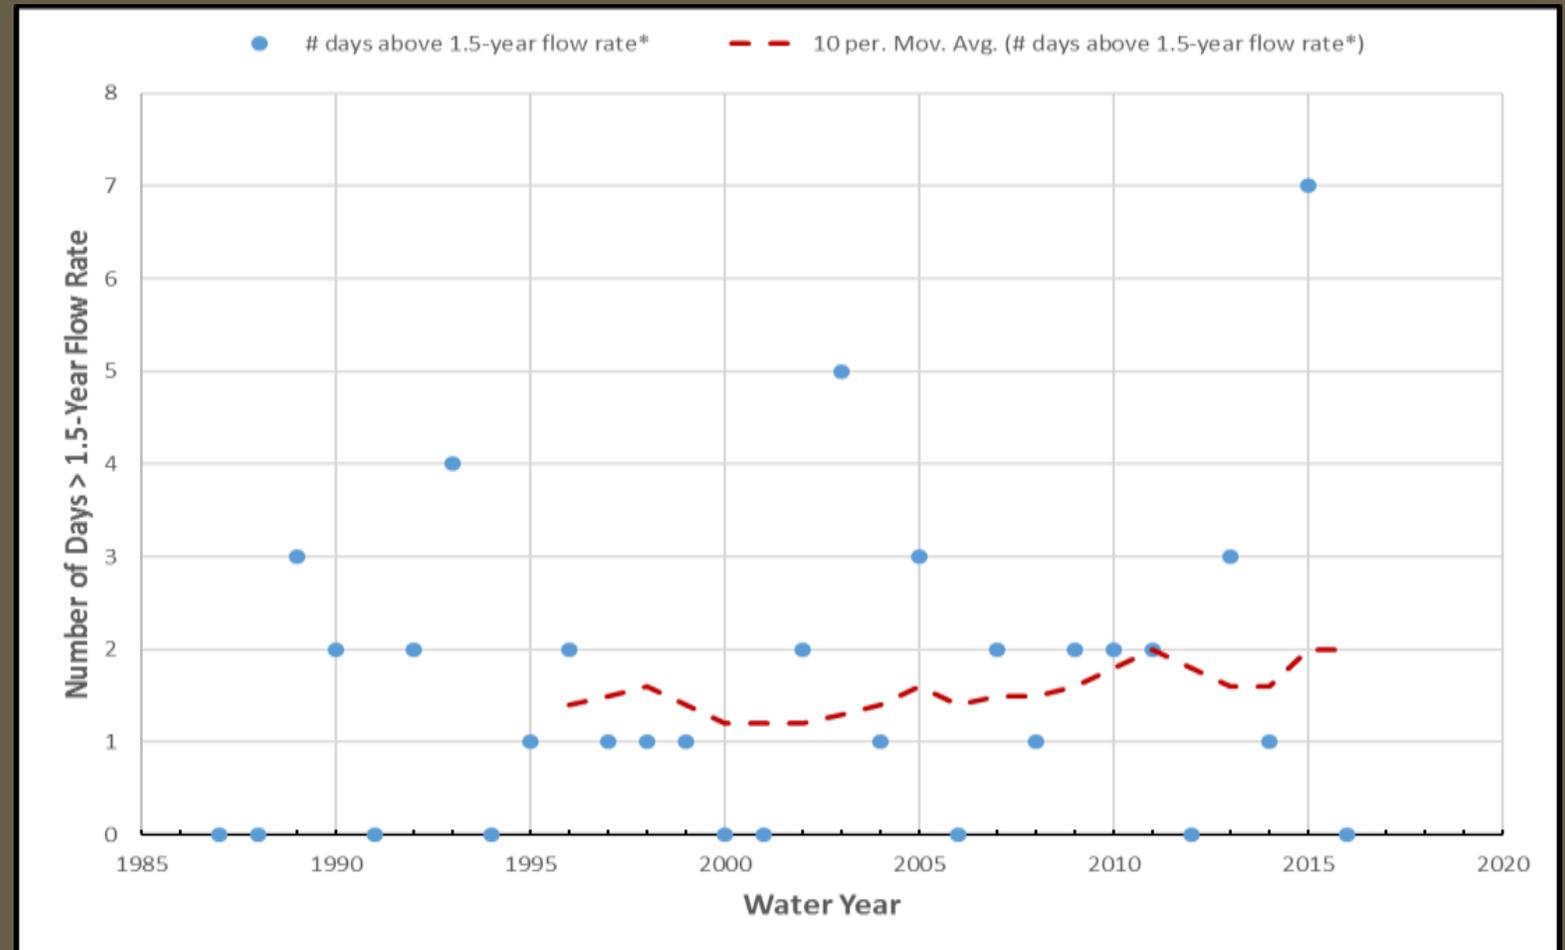
- Channel forming event (bankfull flow) is typically represented by 1.5-year discharge
- Gradual increase in average number of days at or above 1.5-year discharge at the gage
- Increase in number of bankfull flows = more erosion

Frequency of 1.5-Year Discharge at USGS Gage near Lebanon, IN

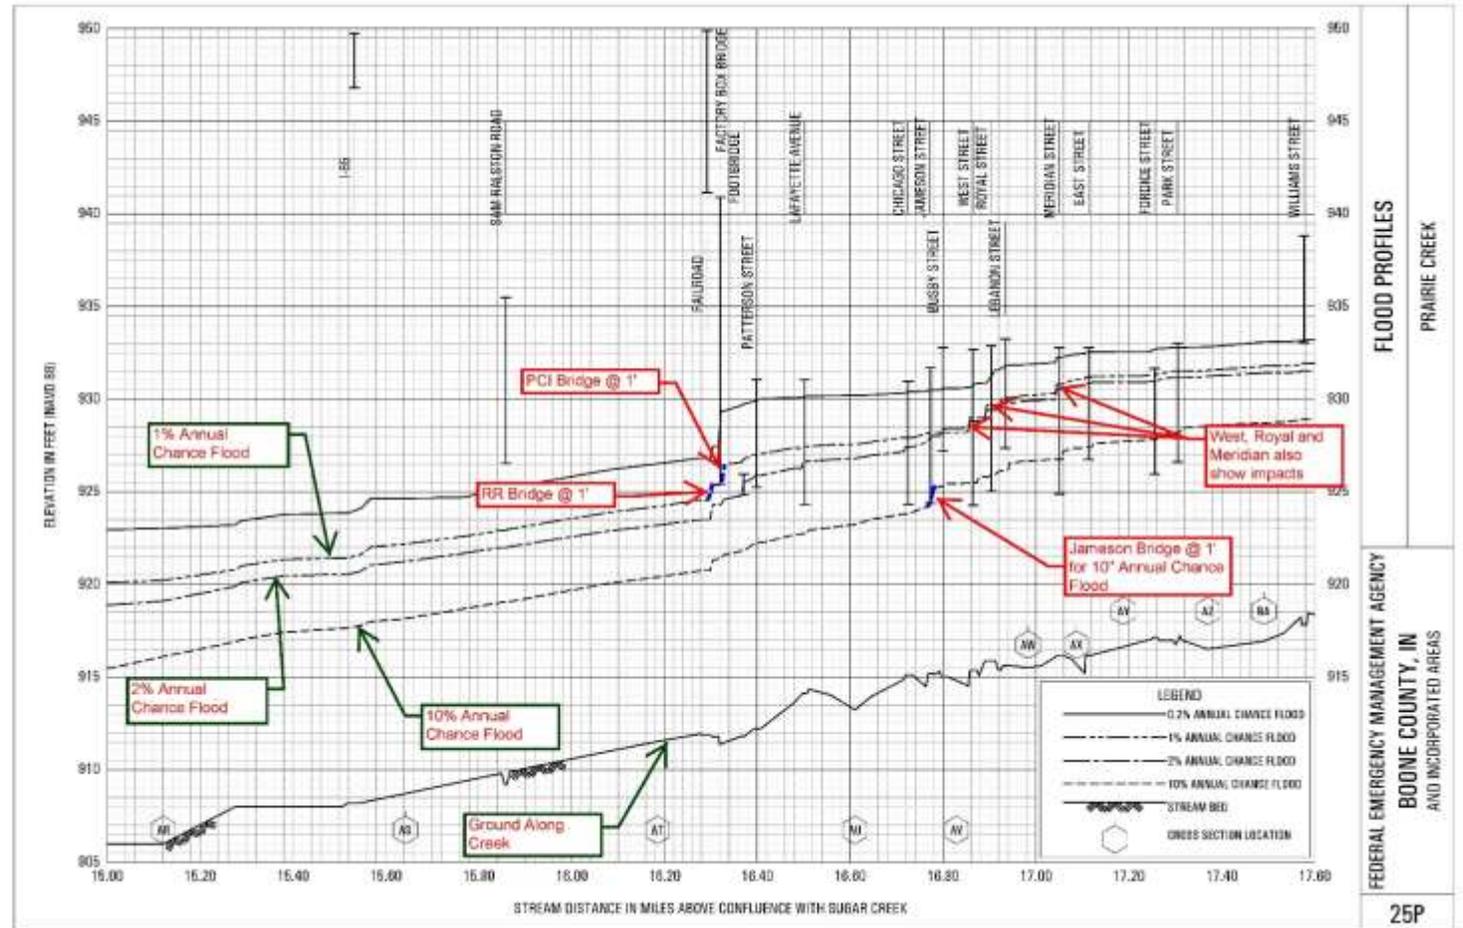
- 15 Bridges within a 1.5-mile reach
- Most all bridges appear inadequate to convey flood flows without a surcharge
- More flow restrictions = more disturbance = more erosion and higher flood levels

Flood Profiles through Lebanon, IN

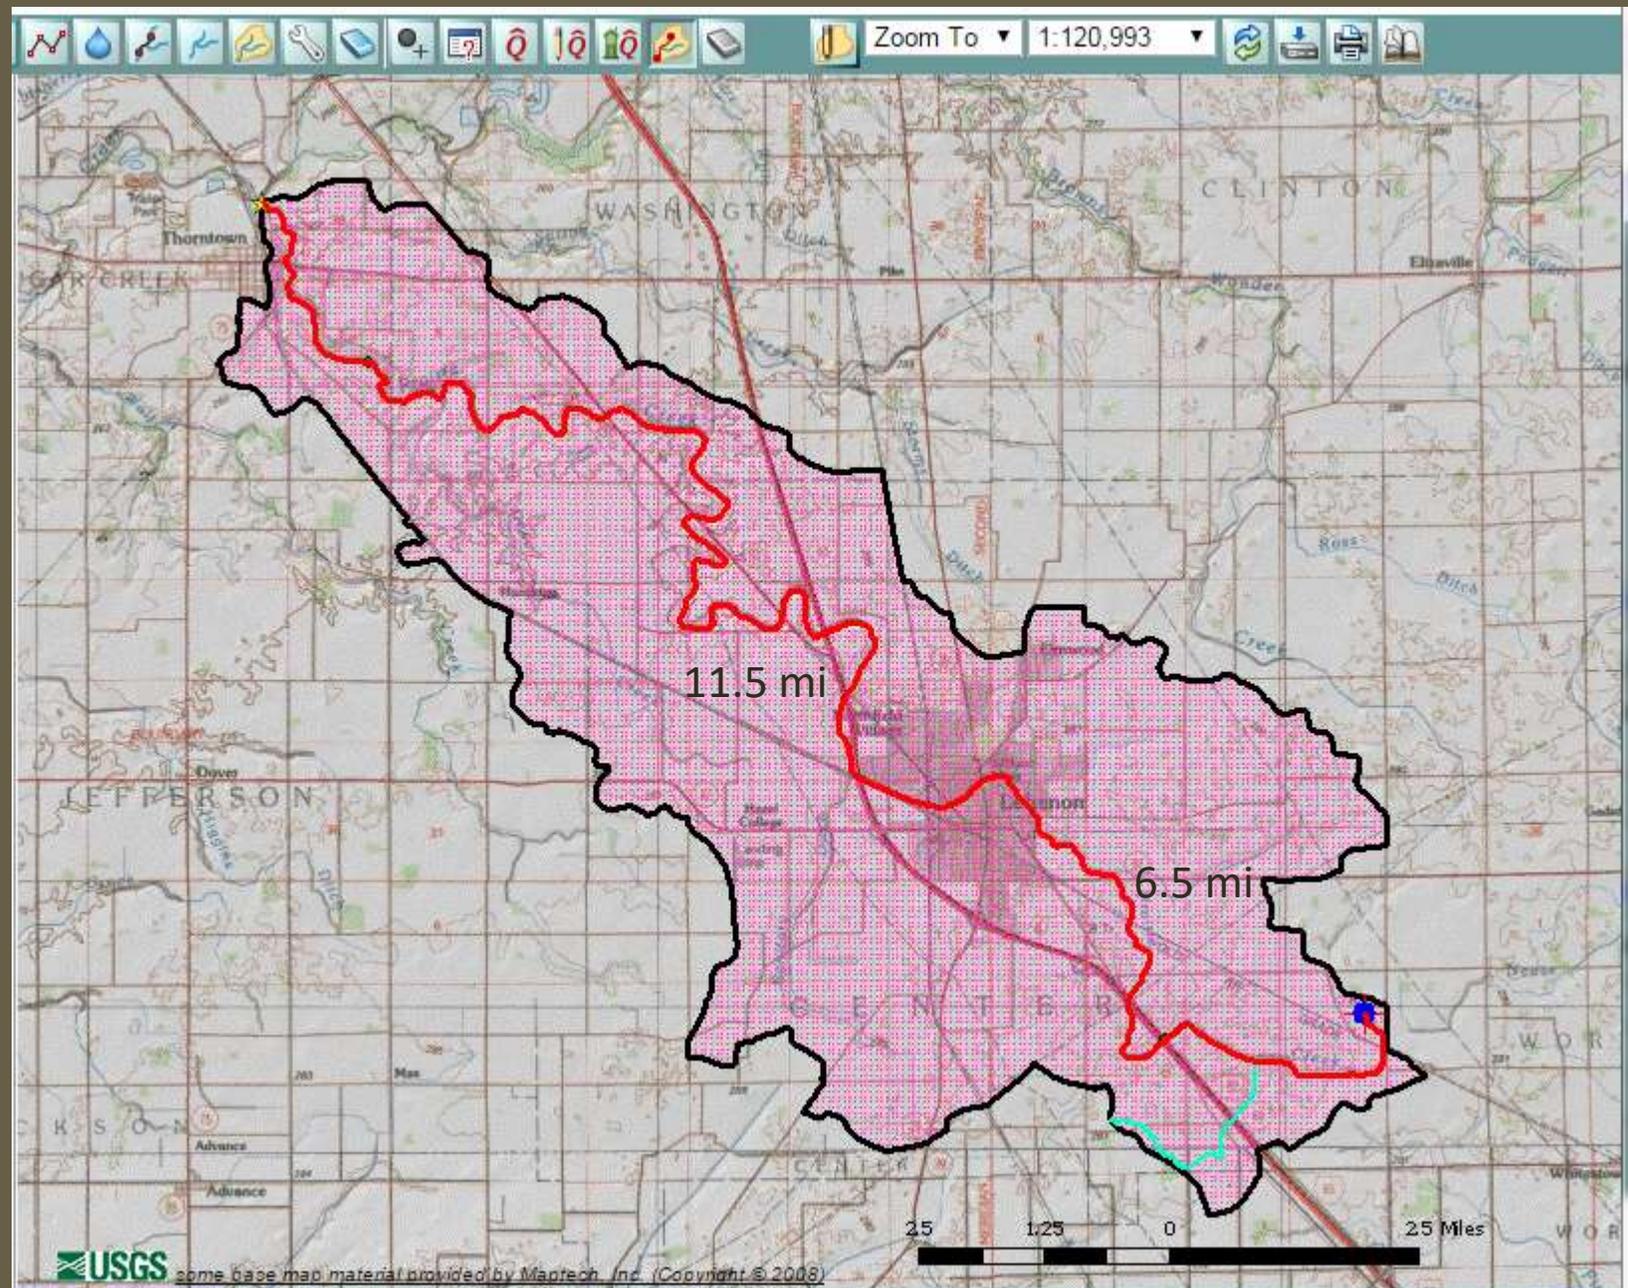
Prairie Creek at Sugar Creek, near Thorntown, Ind.

Here the natural drainage is very poorly developed ... the innumerable lines shown on the map are mostly artificial waterways. The larger ones are dredge ditches 10-15 feet deep straightening the former illdefined [sp] and obstructed course of natural channels while the smaller ones are outlets for depressions that had little or no connection with each other or with the creeks.

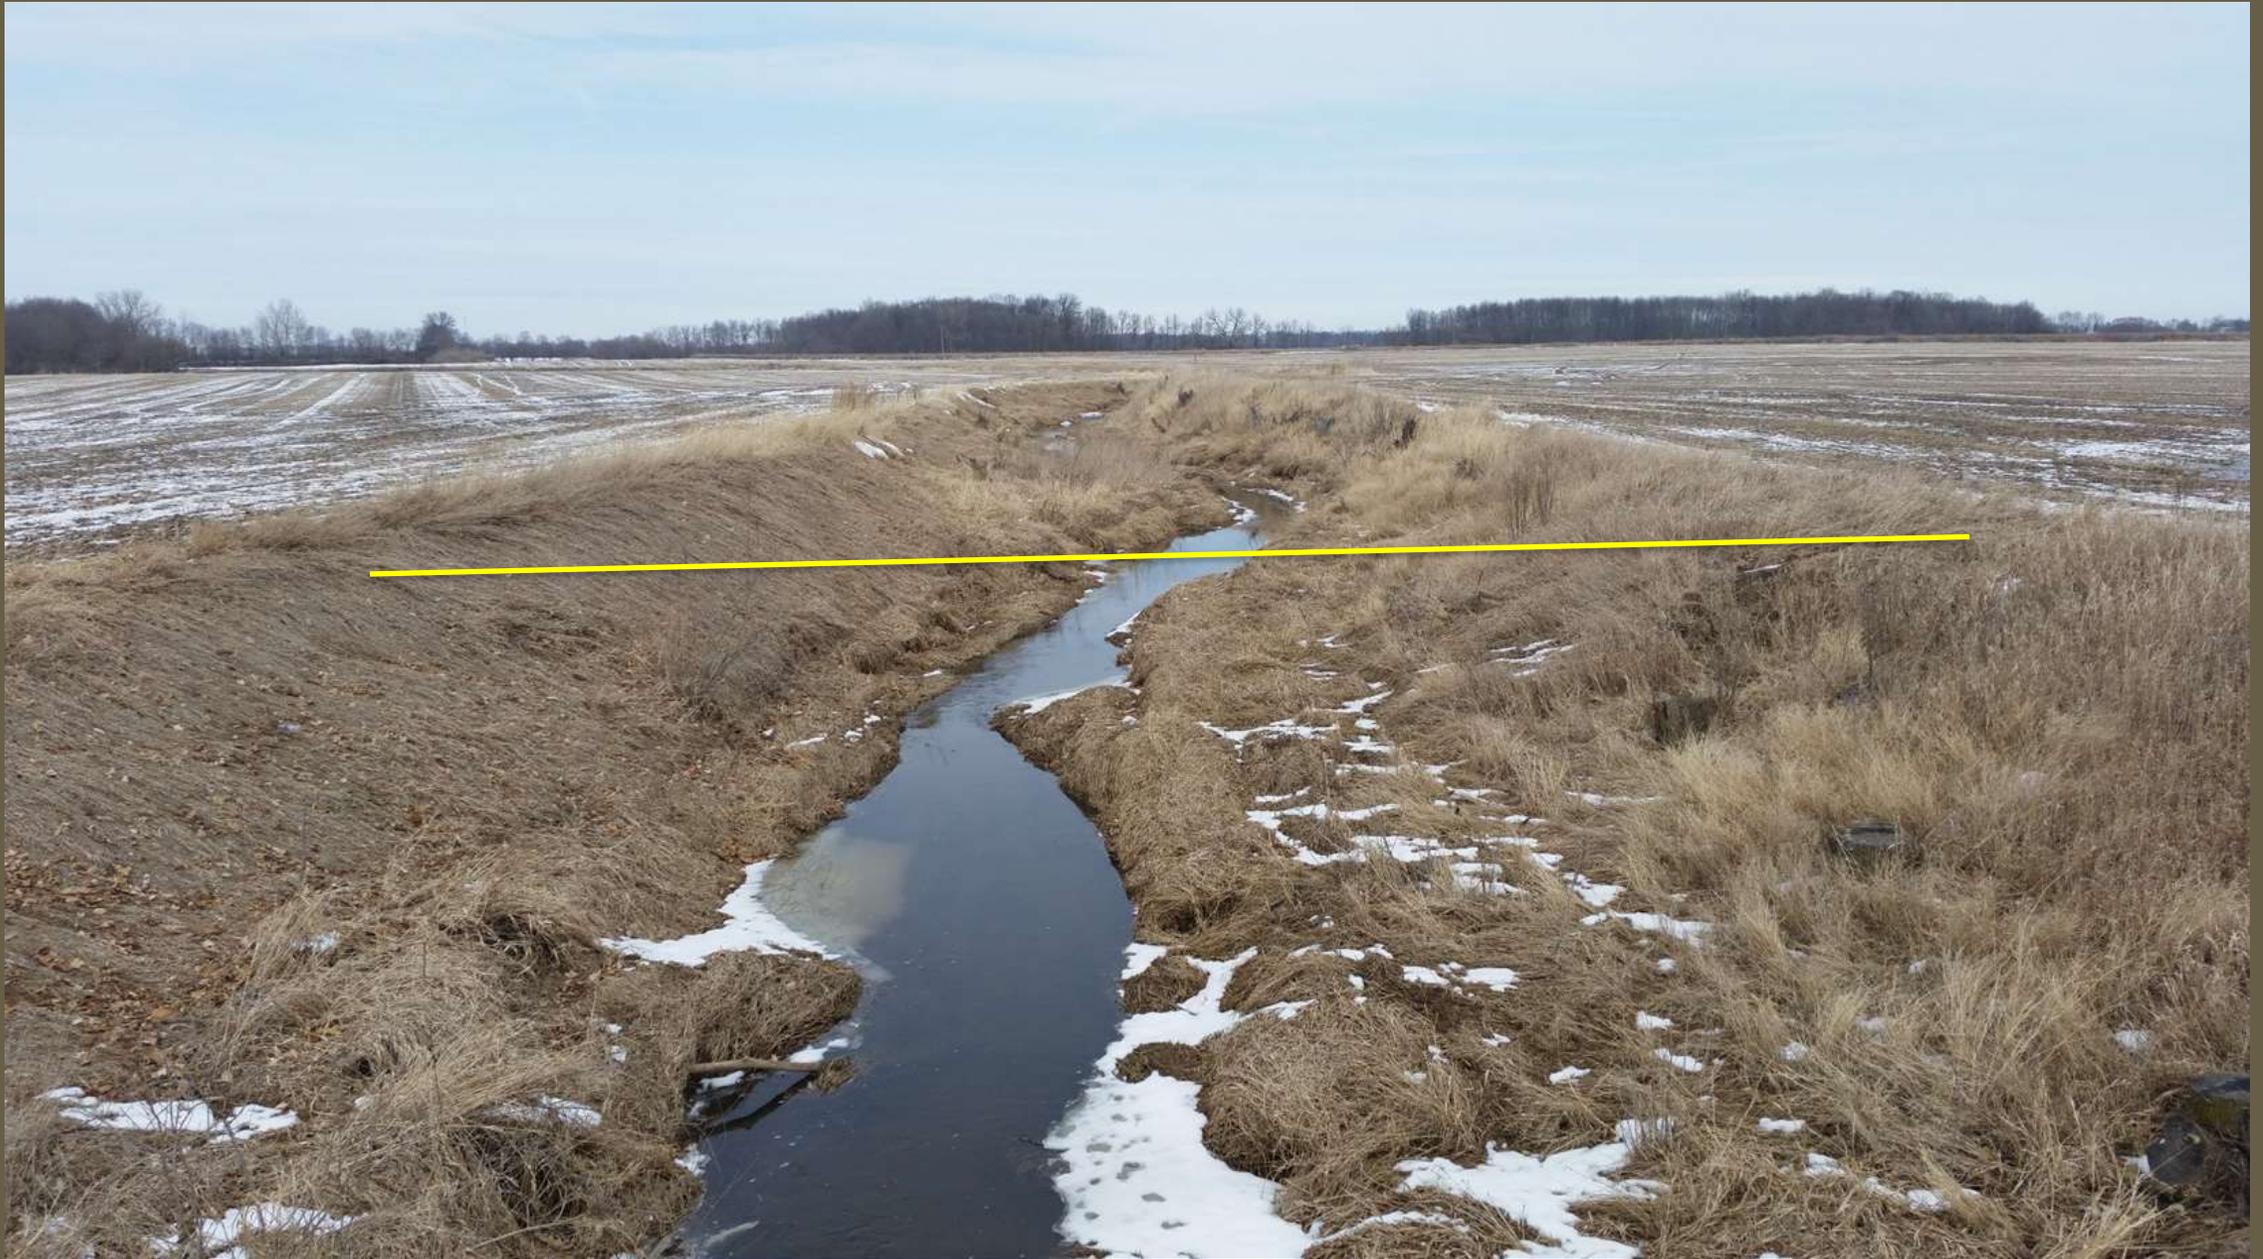
Prairie Creek at CR 100 S, channel dimensions 65 ft, 12ft, 9ft ( $A = 347 \text{ ft}^2$ ), note developing floodplain (Predicted W 39.2, D2.3,  $A = 90$ )

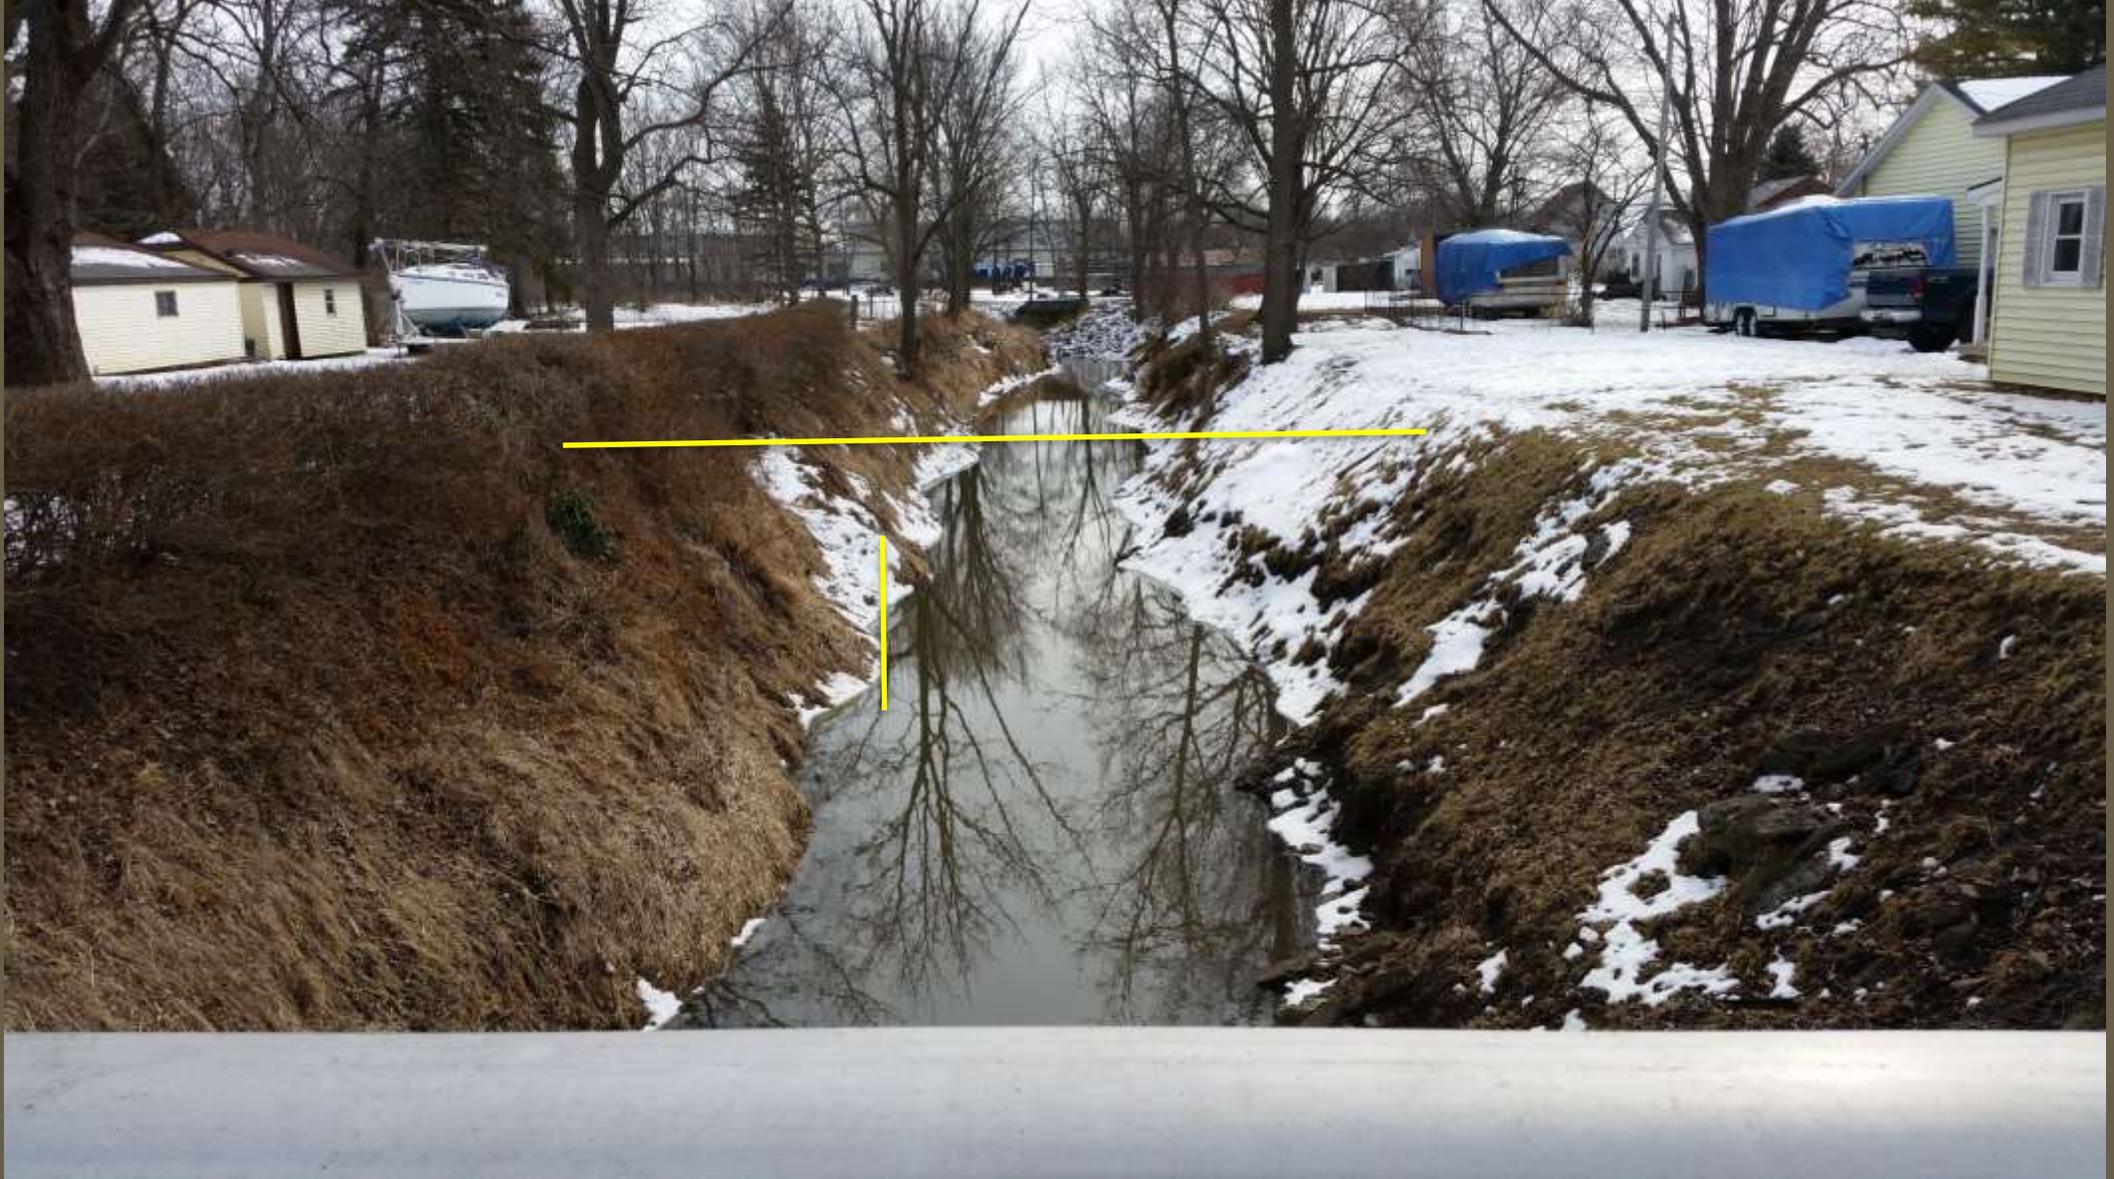
Prairie Creek looking downstream near Grant and E. Main, Lebanon  
Channel dimensions are 32 ft x12 ft x 9 ft ( $A=198 \text{ ft}^2$ ), predicted floodprone depth approx. 5 ft

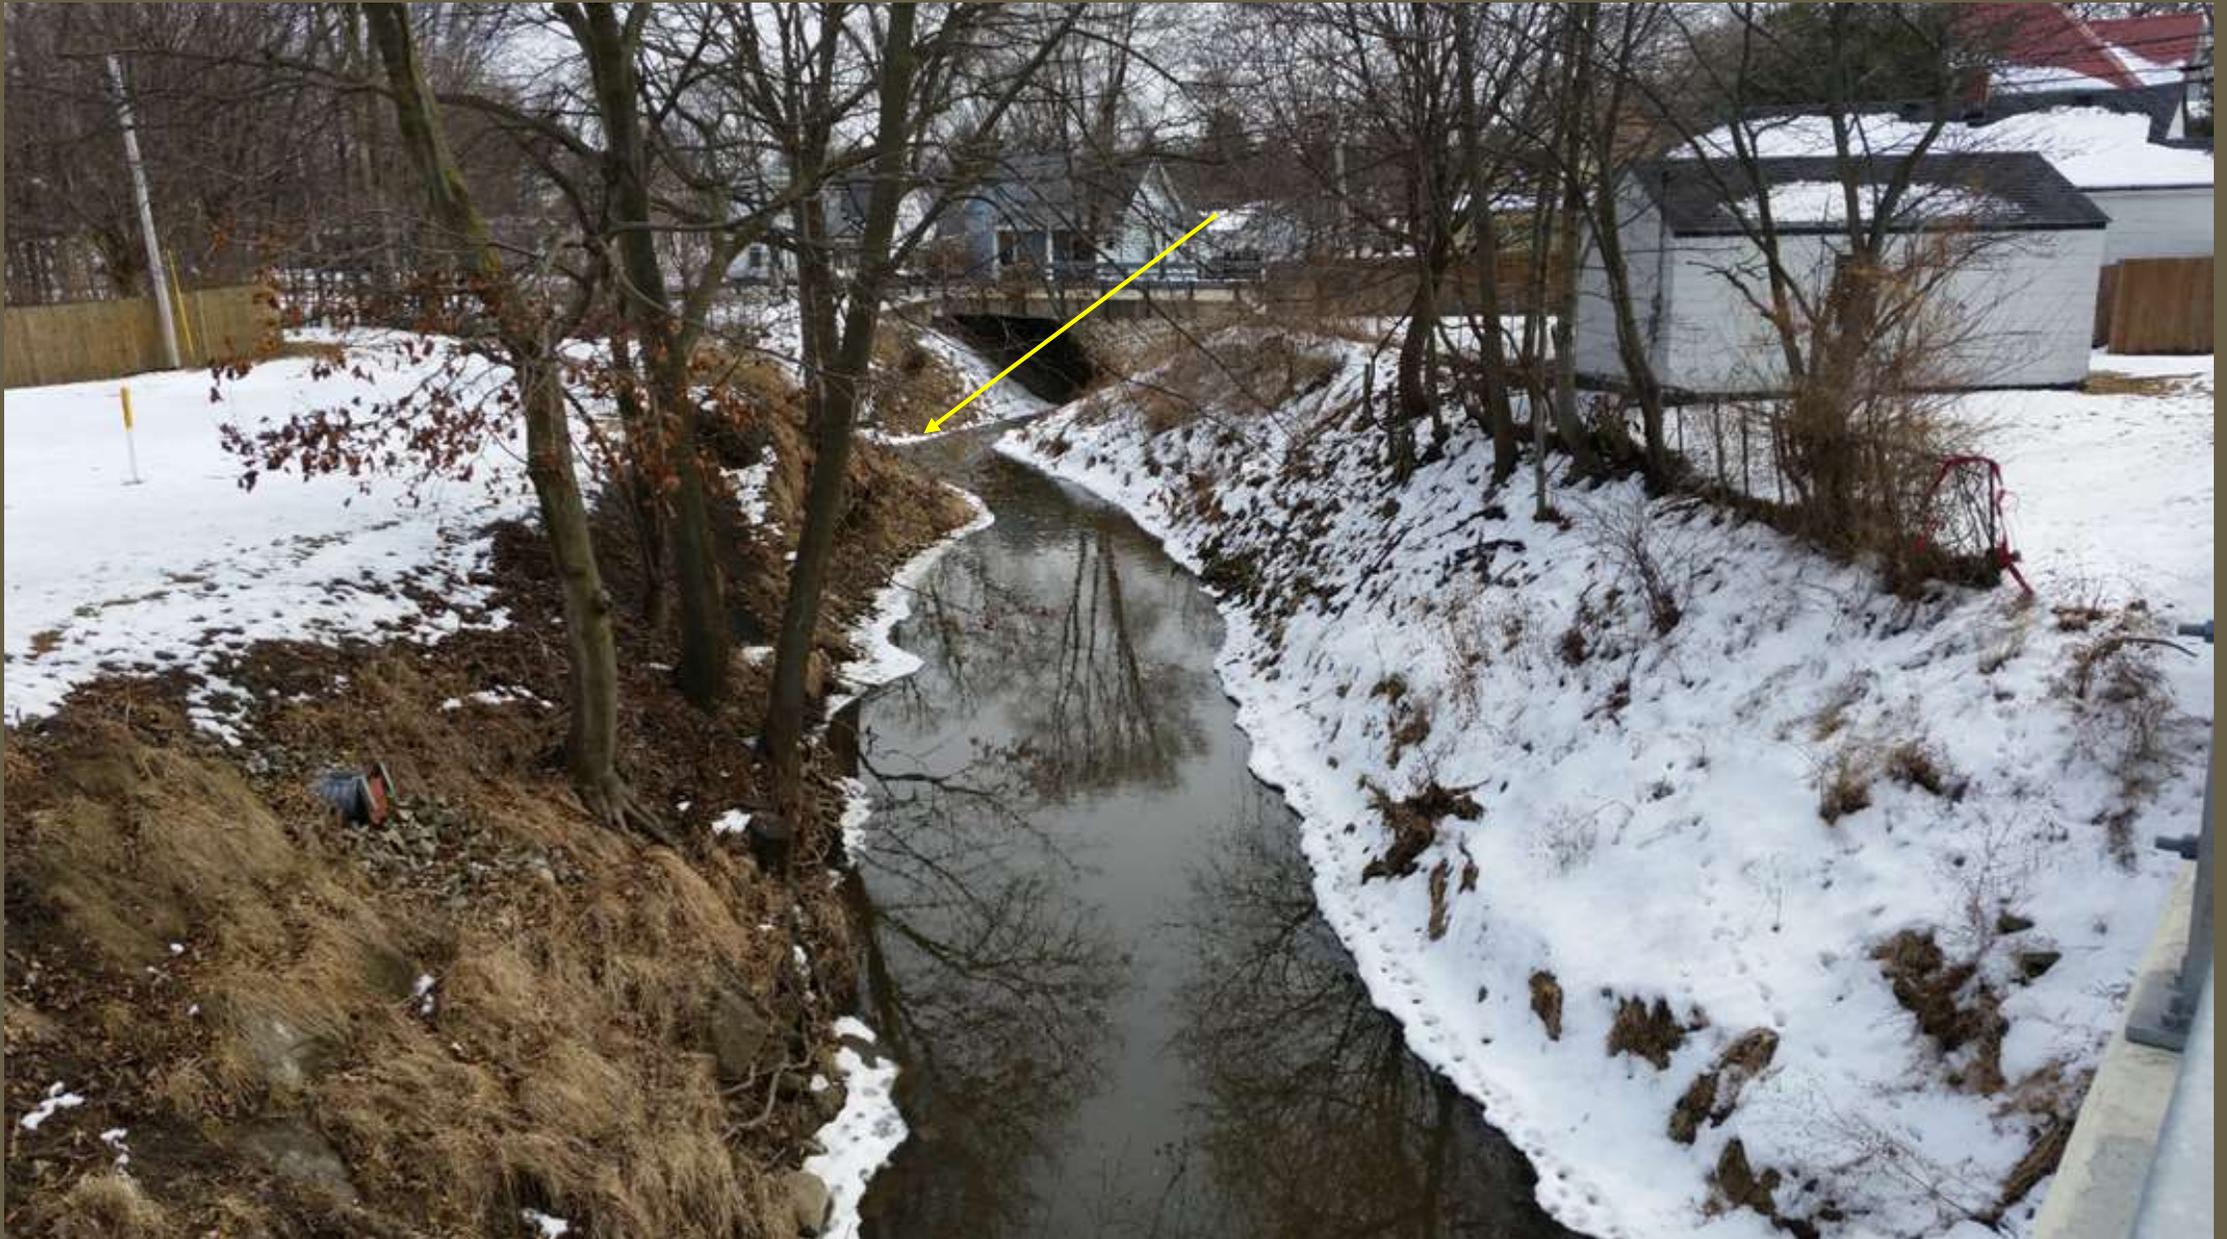
Looking upstream from the N. Grant Street Bridge. The confluence with Mann Ditch (flowing in on the left, yellow arrow) can be seen in the upper center of the image.

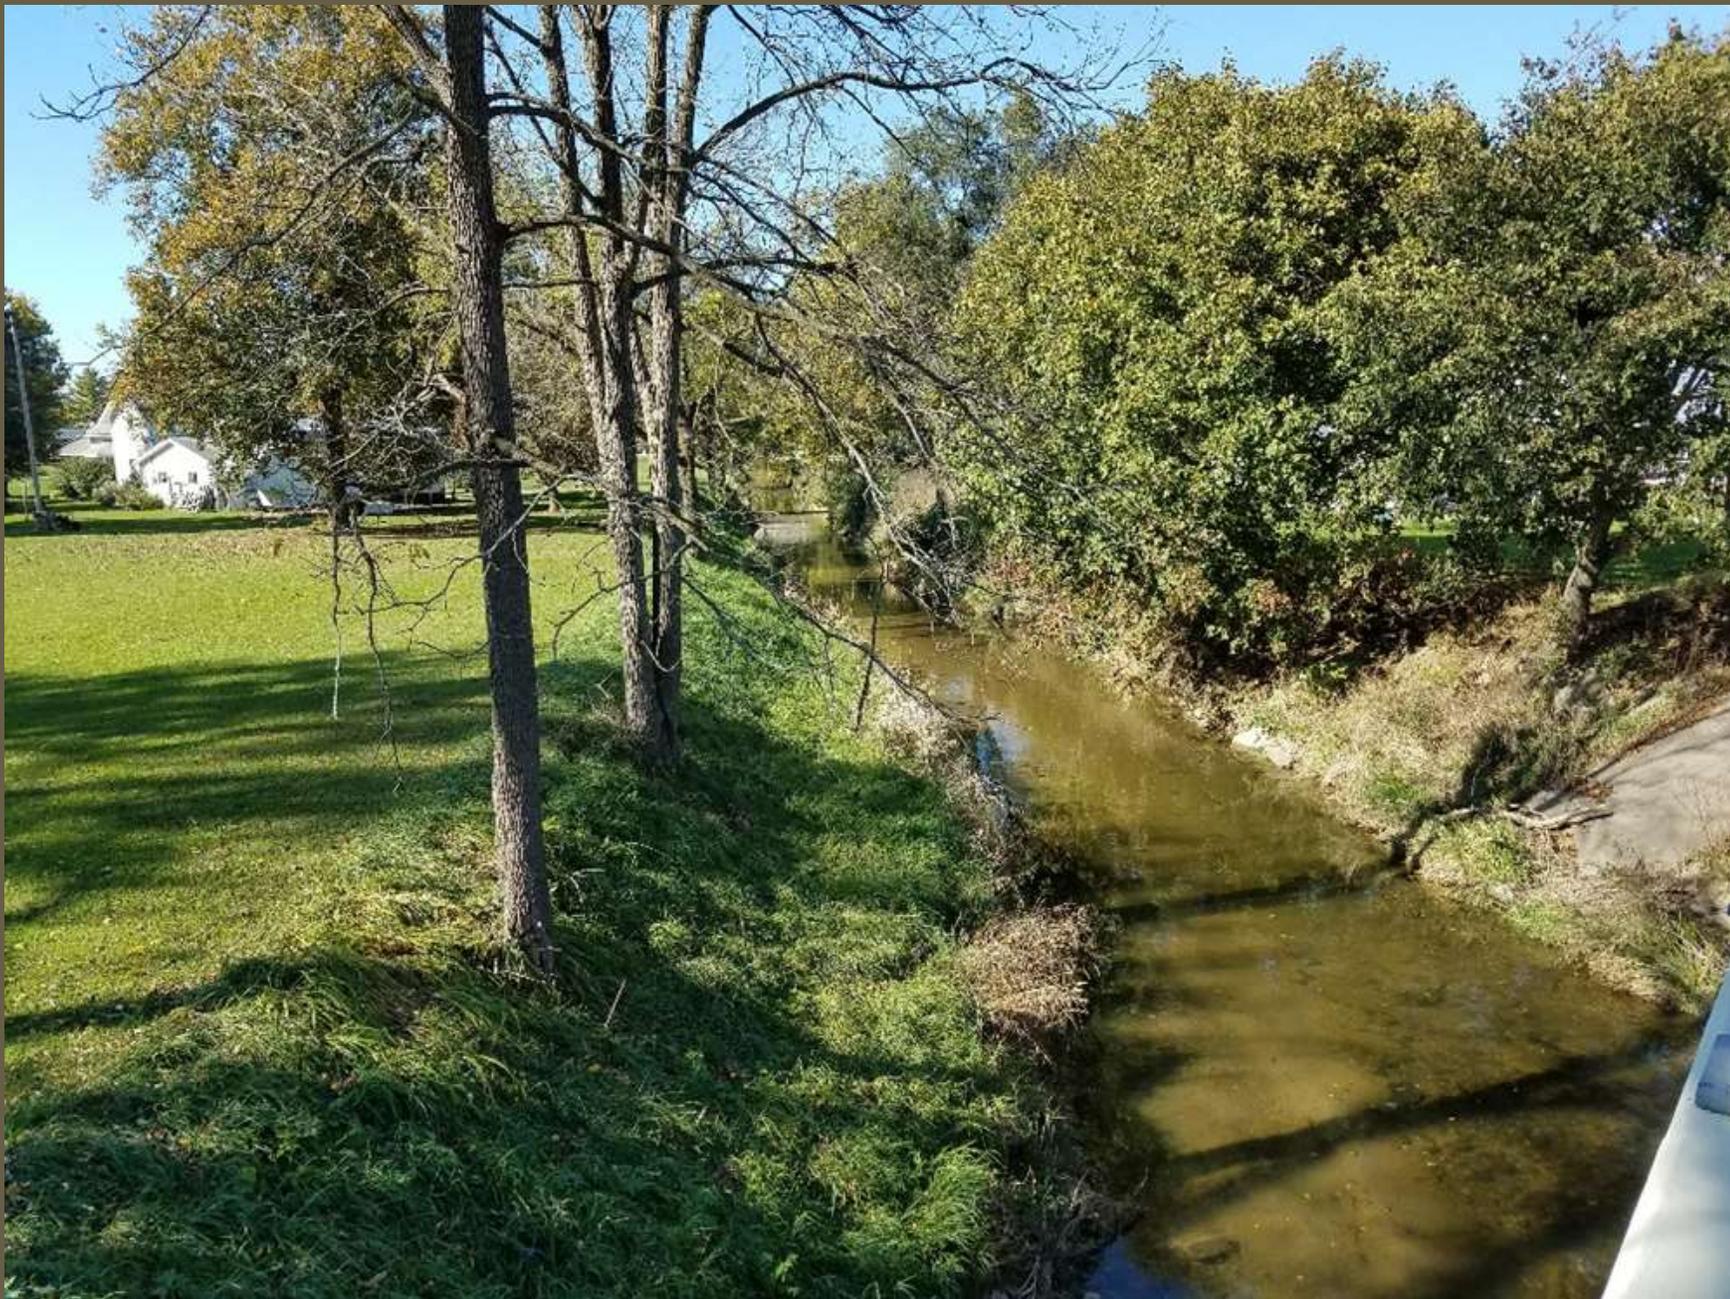
Looking downstream from the Grant Street Bridge. Note stable floodplain bench developing on the inside of the bend.

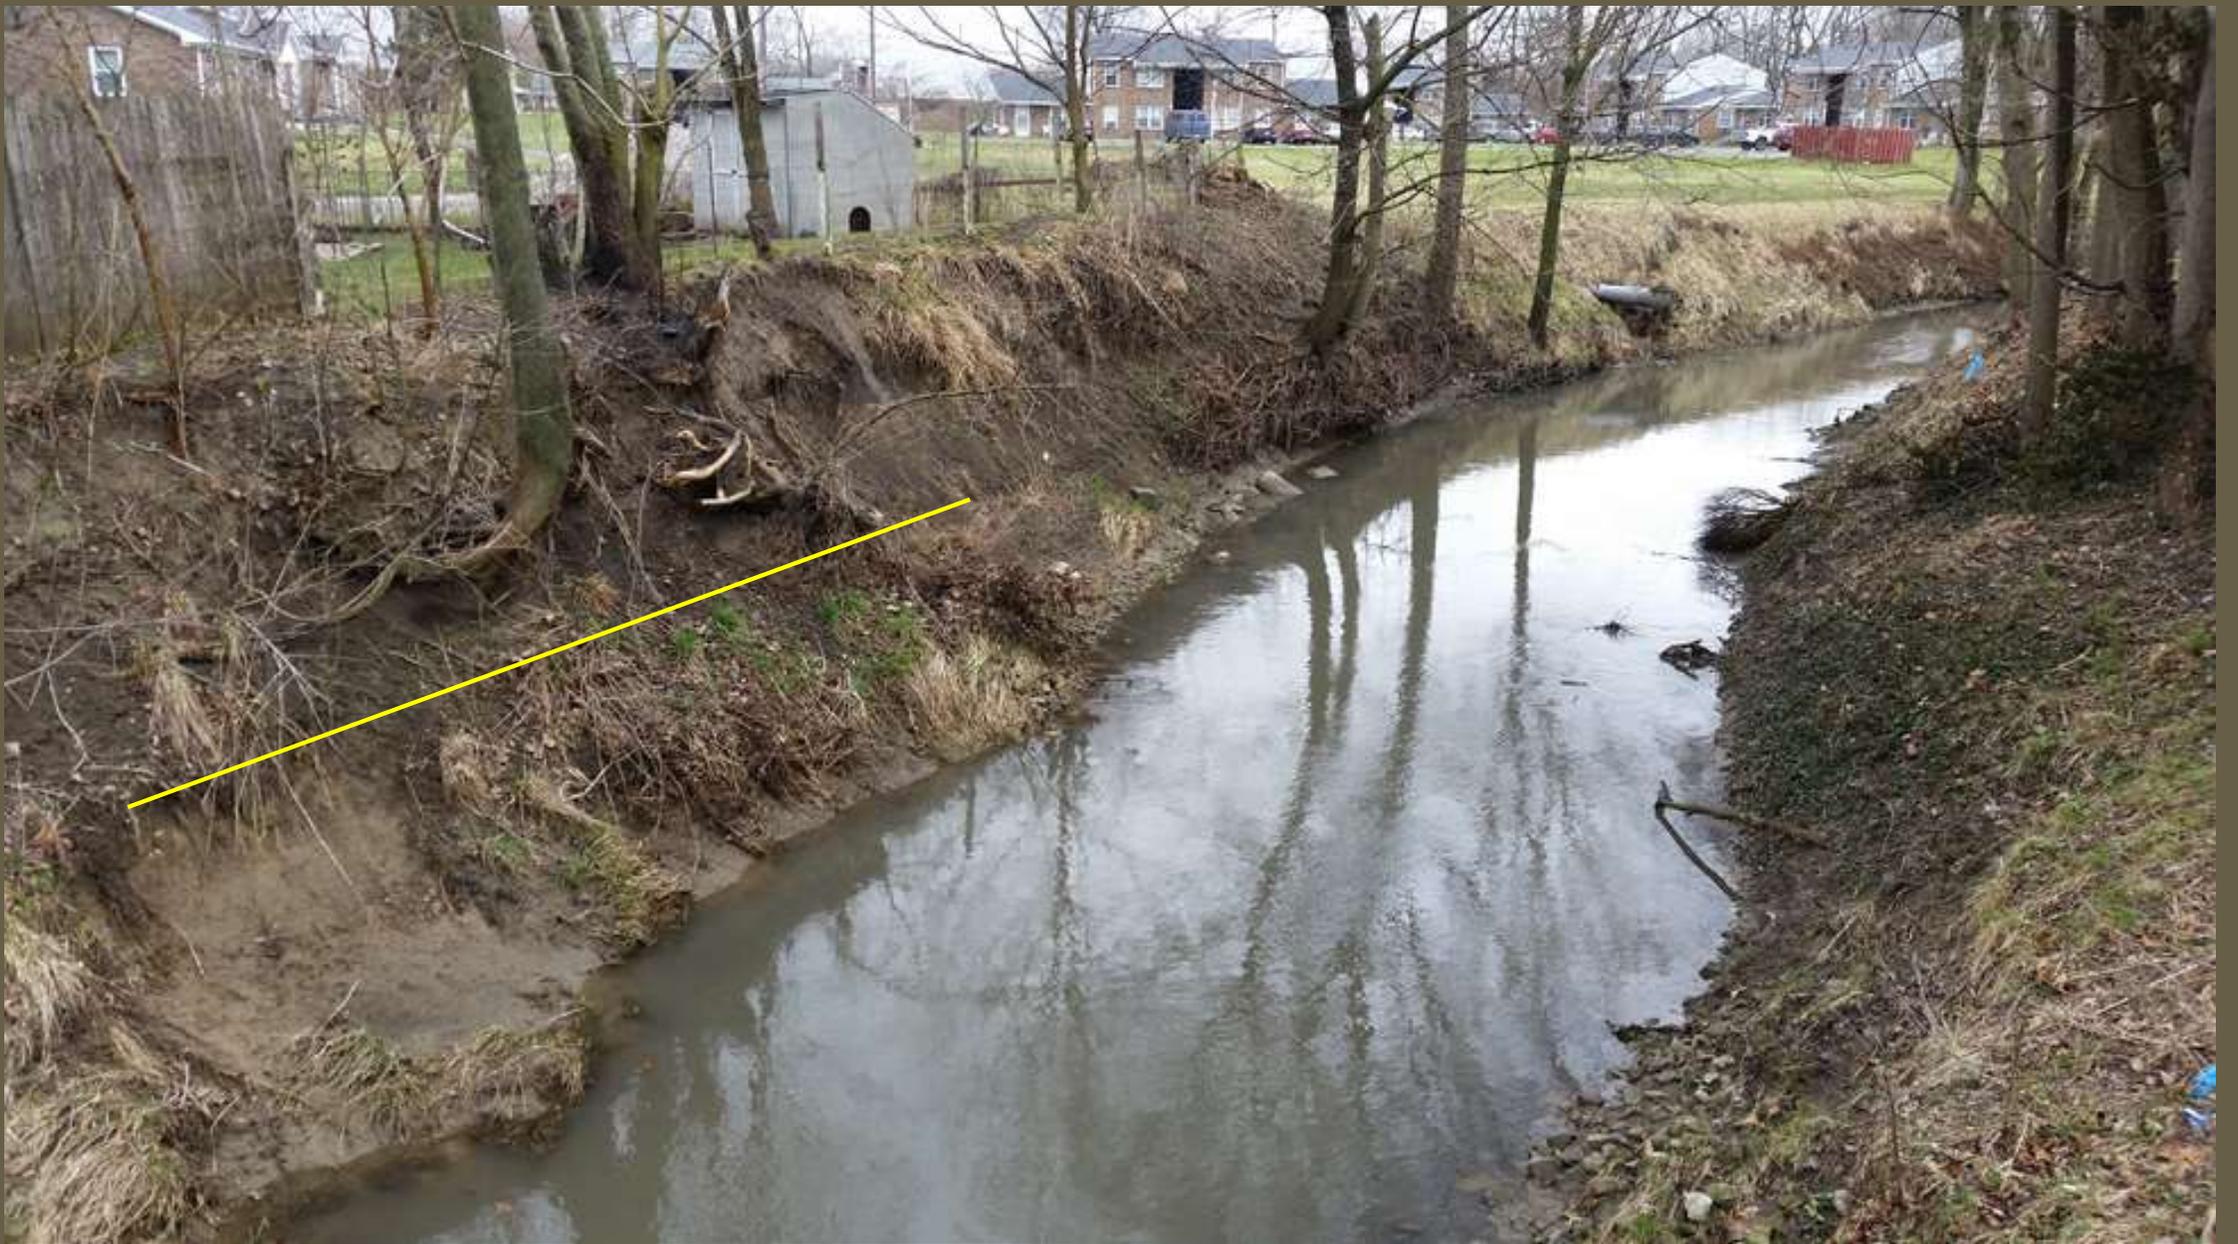
Downstream from N Park Street. The right bank in this image is higher than the left bank. A till contact is indicated by the yellow line. The soil above is a silty loam, and easily eroded.
