# A LITTLE ROOM FOR THE RIVER PLEASE !!!

## The case of Prairie Creek in Lebanon, Boone County, Indiana

INAFSM 2017 Annual Conference

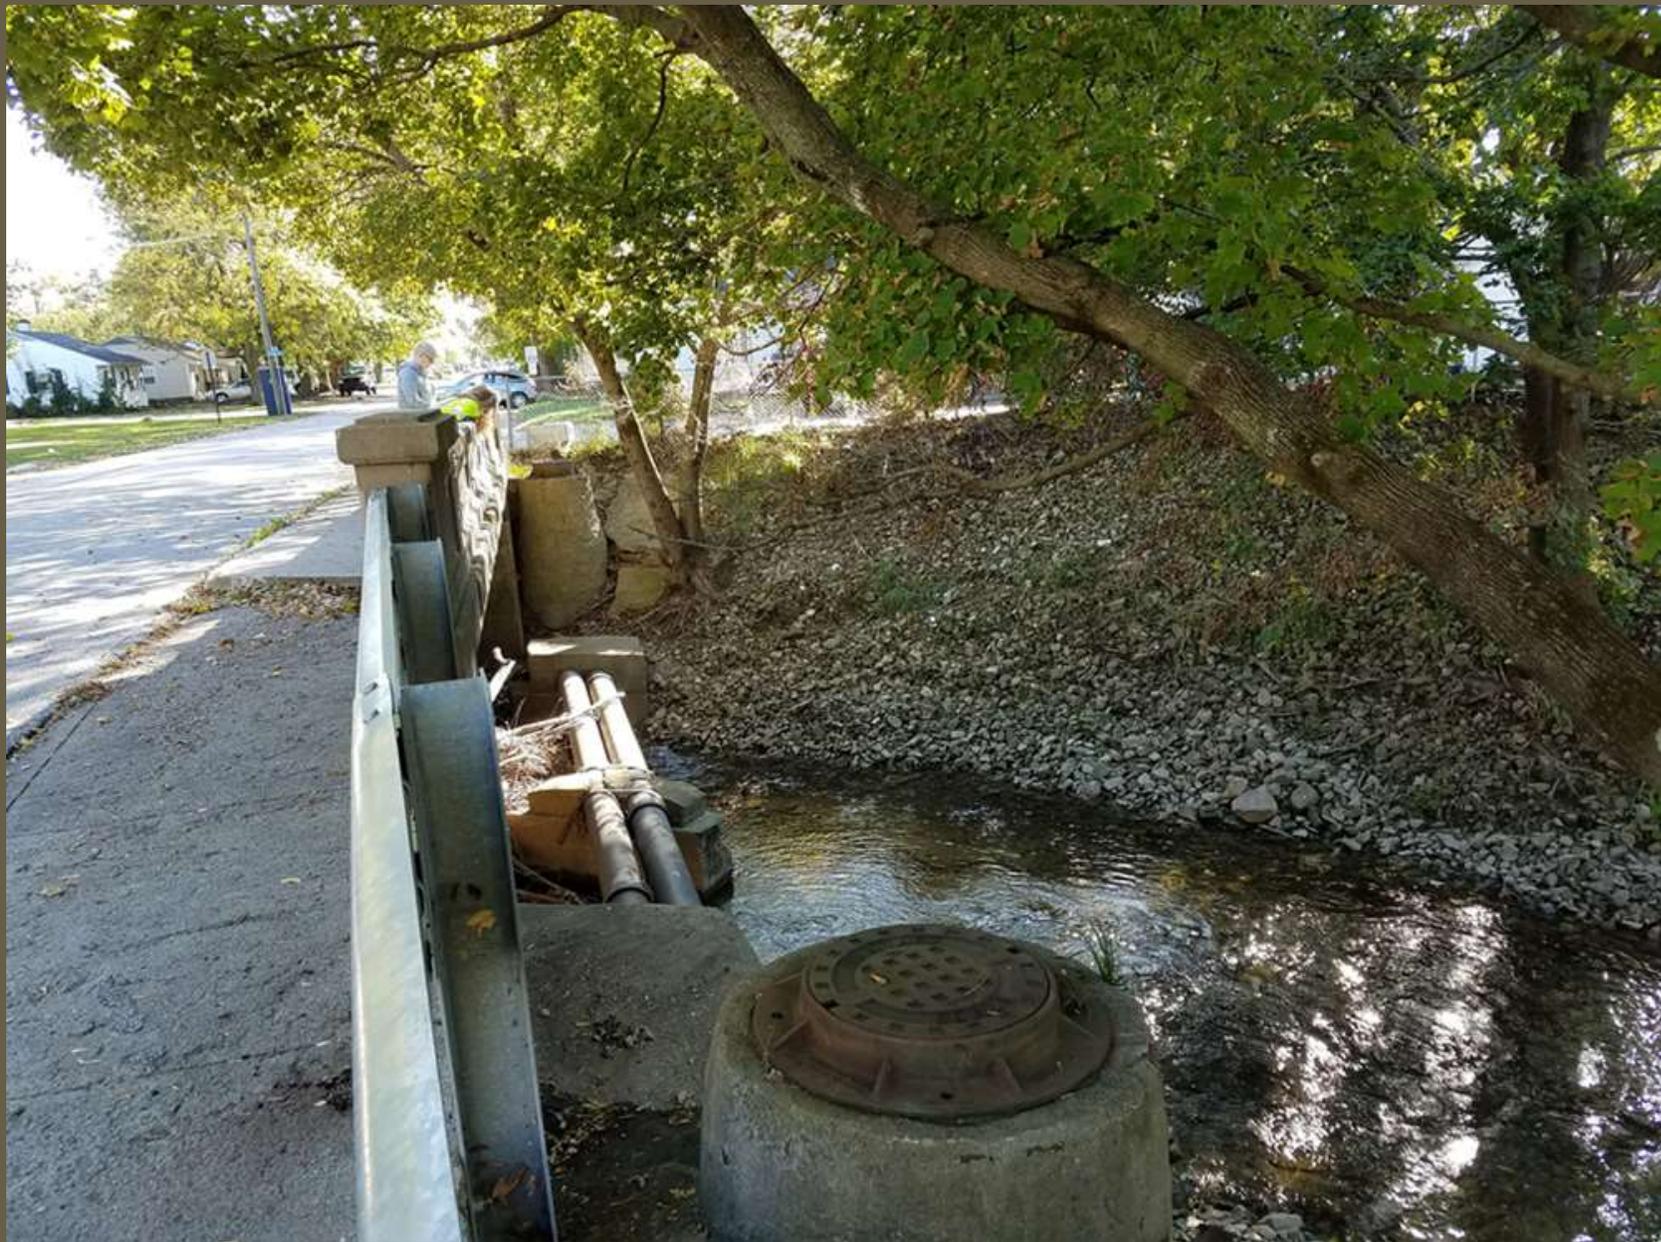
View of the Park Street Bridge taken from north side of bridge. Rock on left bank extends to top of bank. Note debris in the pipes

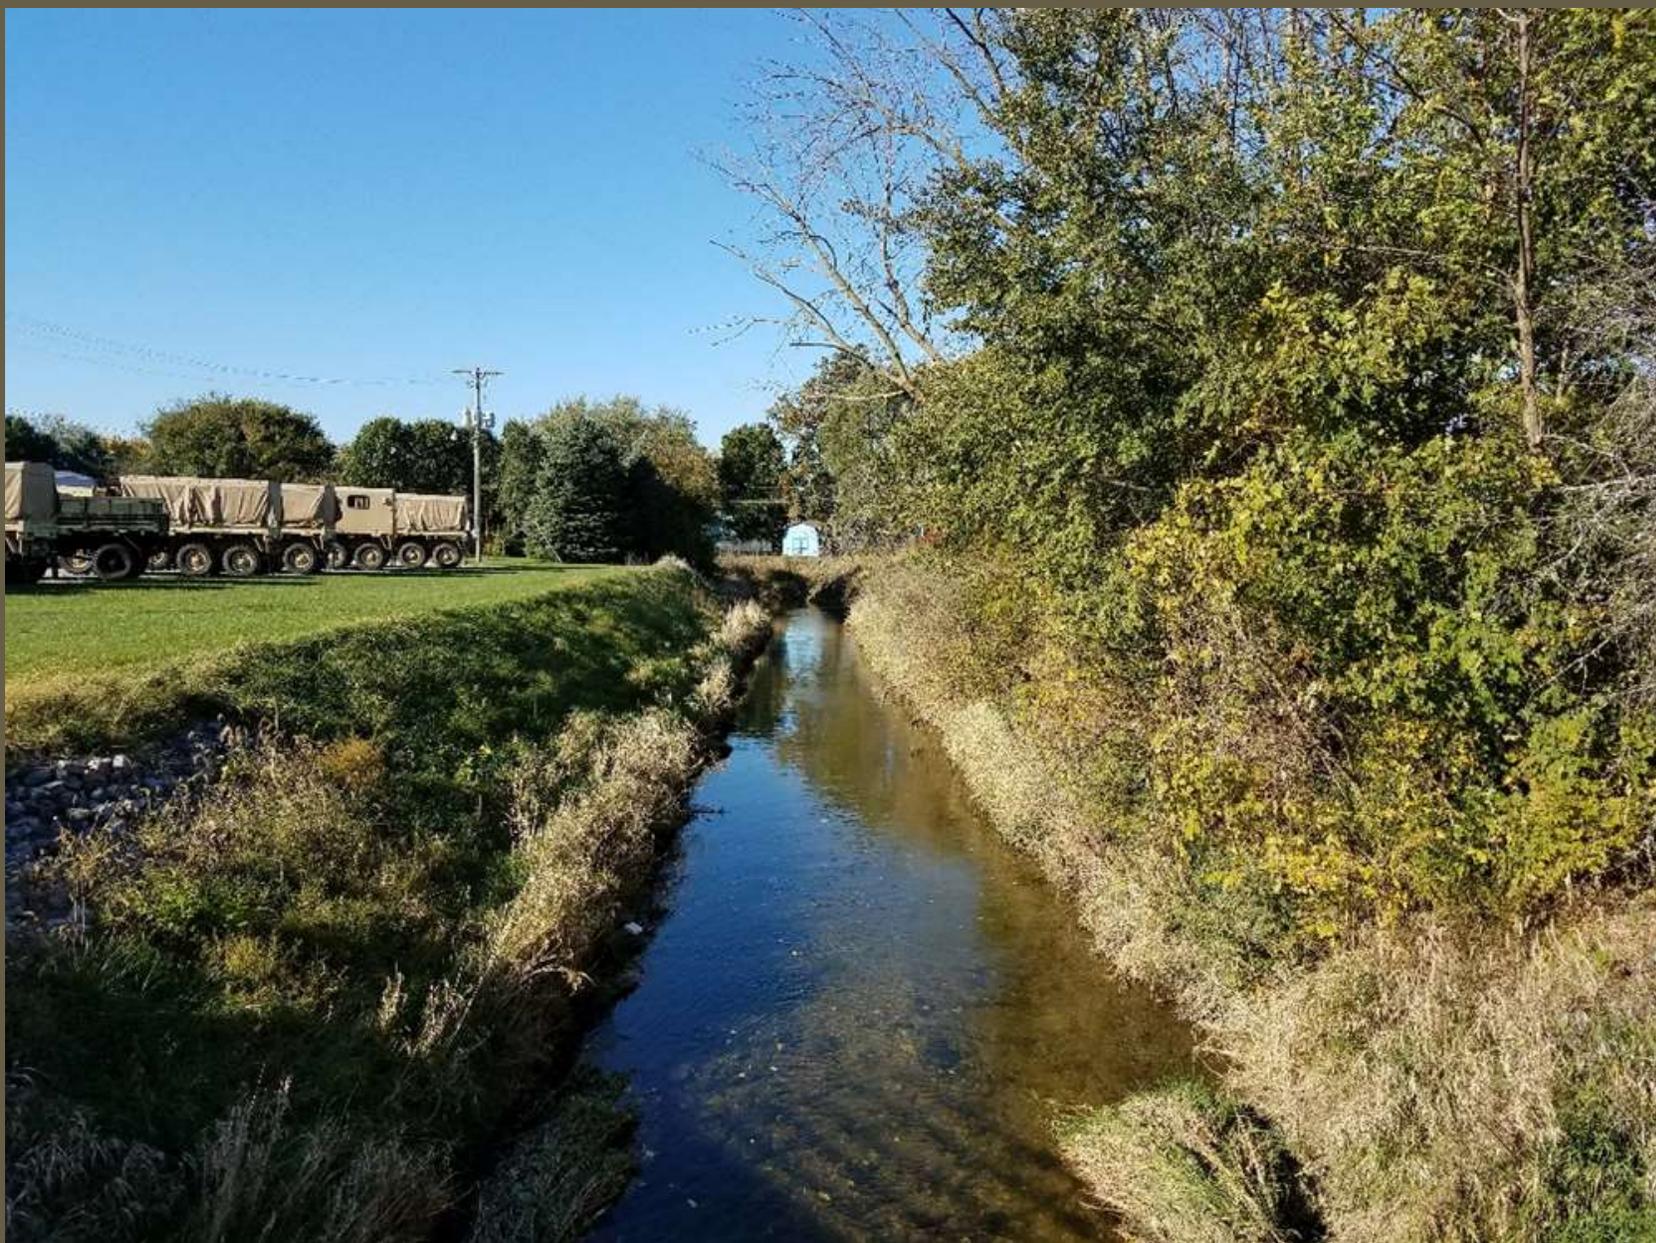
Downstream from E. Fordice Street. The entire Fordice to East Street reach has been armored with gabions. The left bank in the foreground shows the development of a small bench. Vegetation on the left bank is minimal. The right bank is steeper and more protected by the extensive woody vegetation.

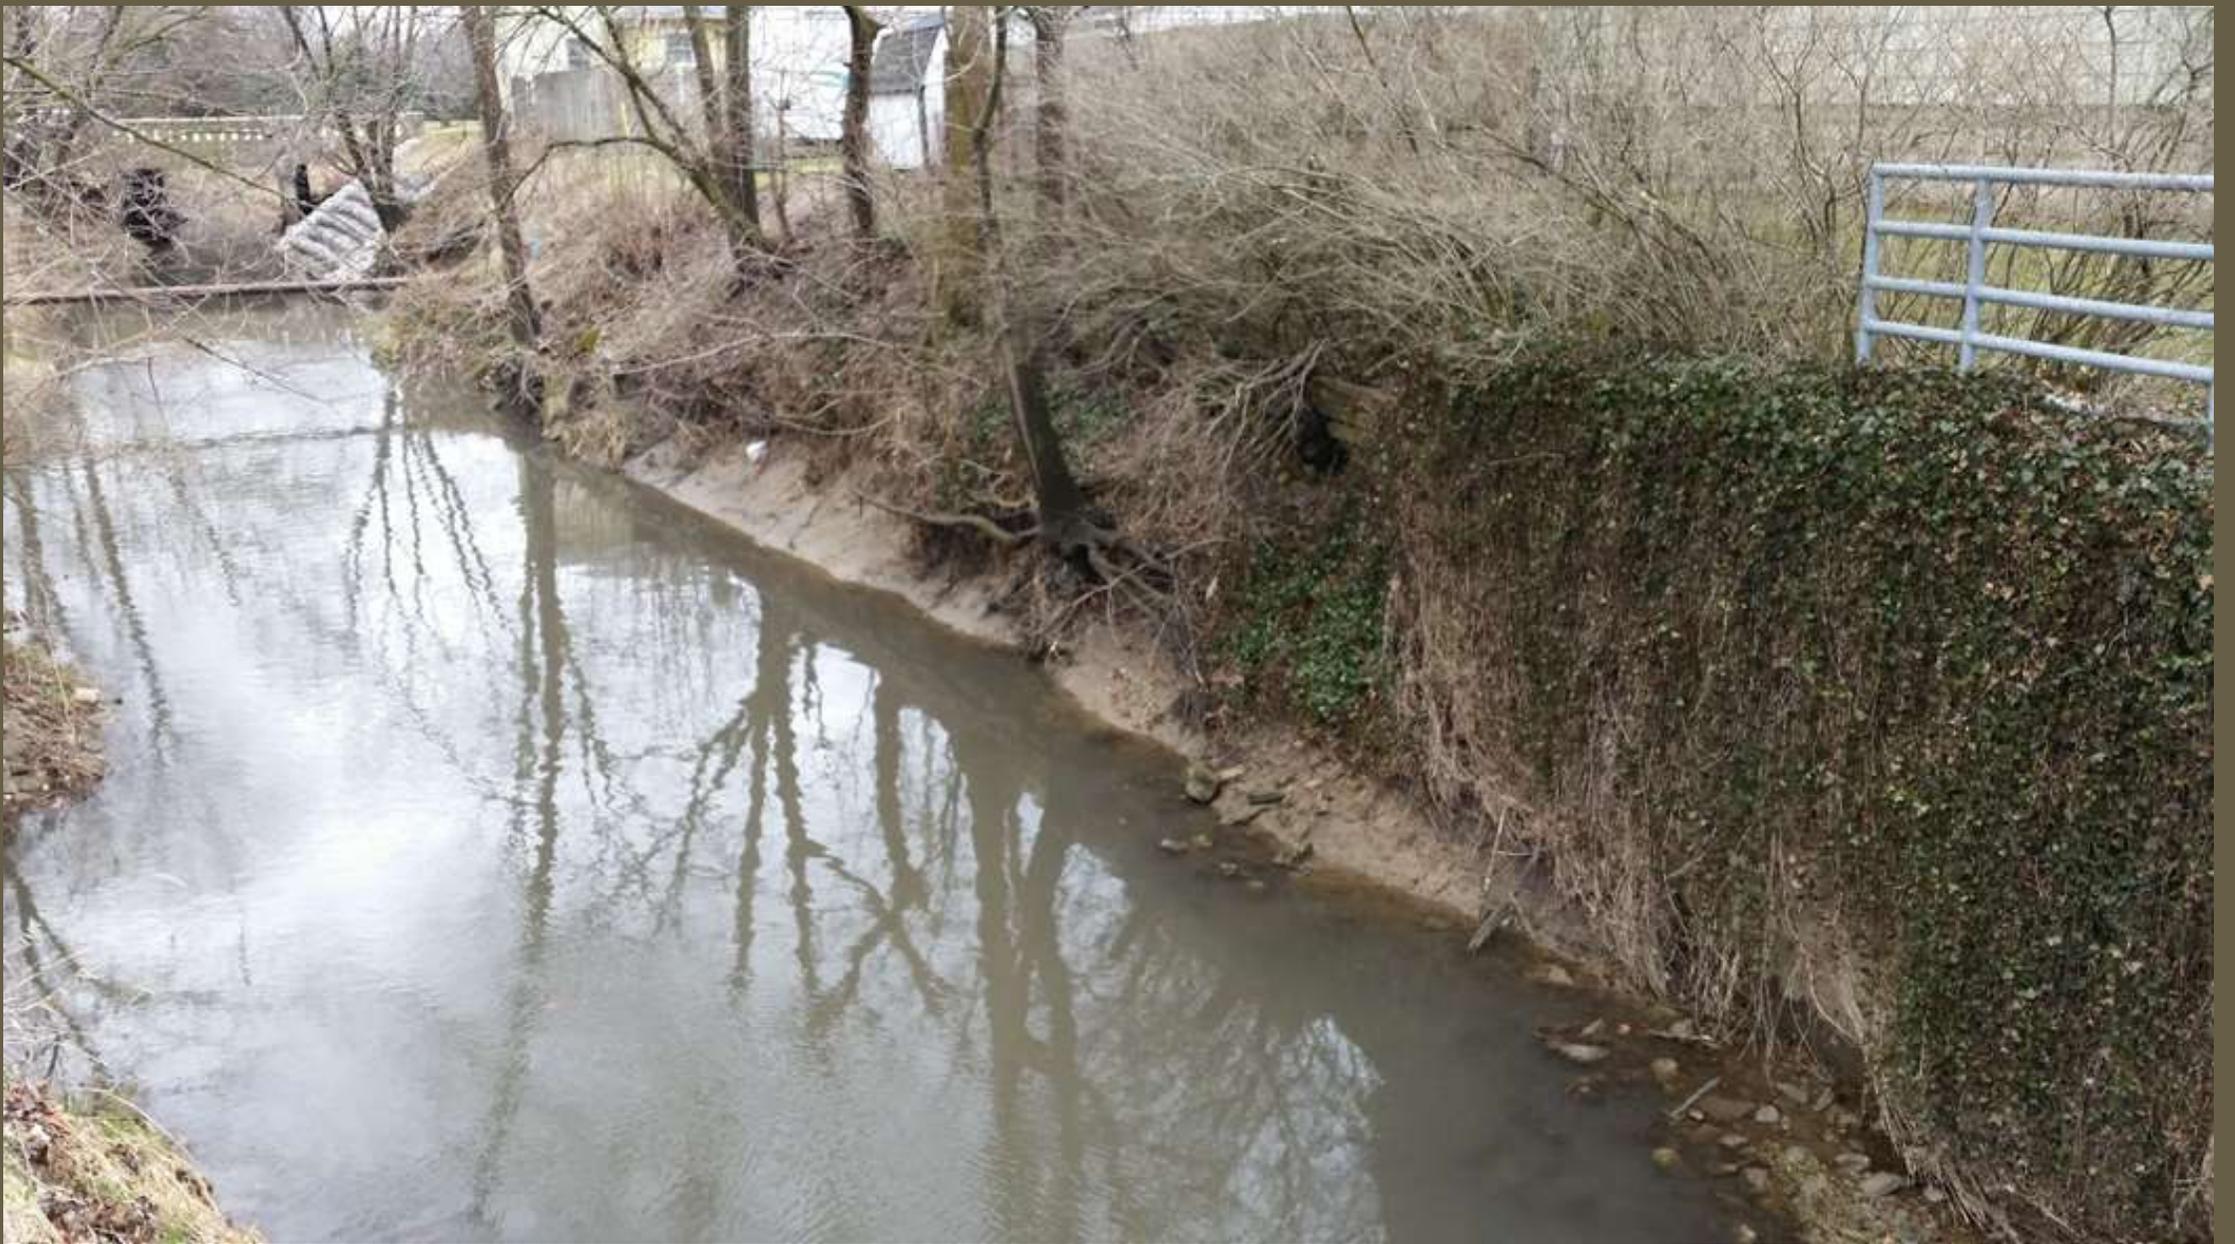
Left bank looking upstream from the Meridian Street Bridge. The scour line is visible along the left bank. Note the gabion baskets at the upstream end.

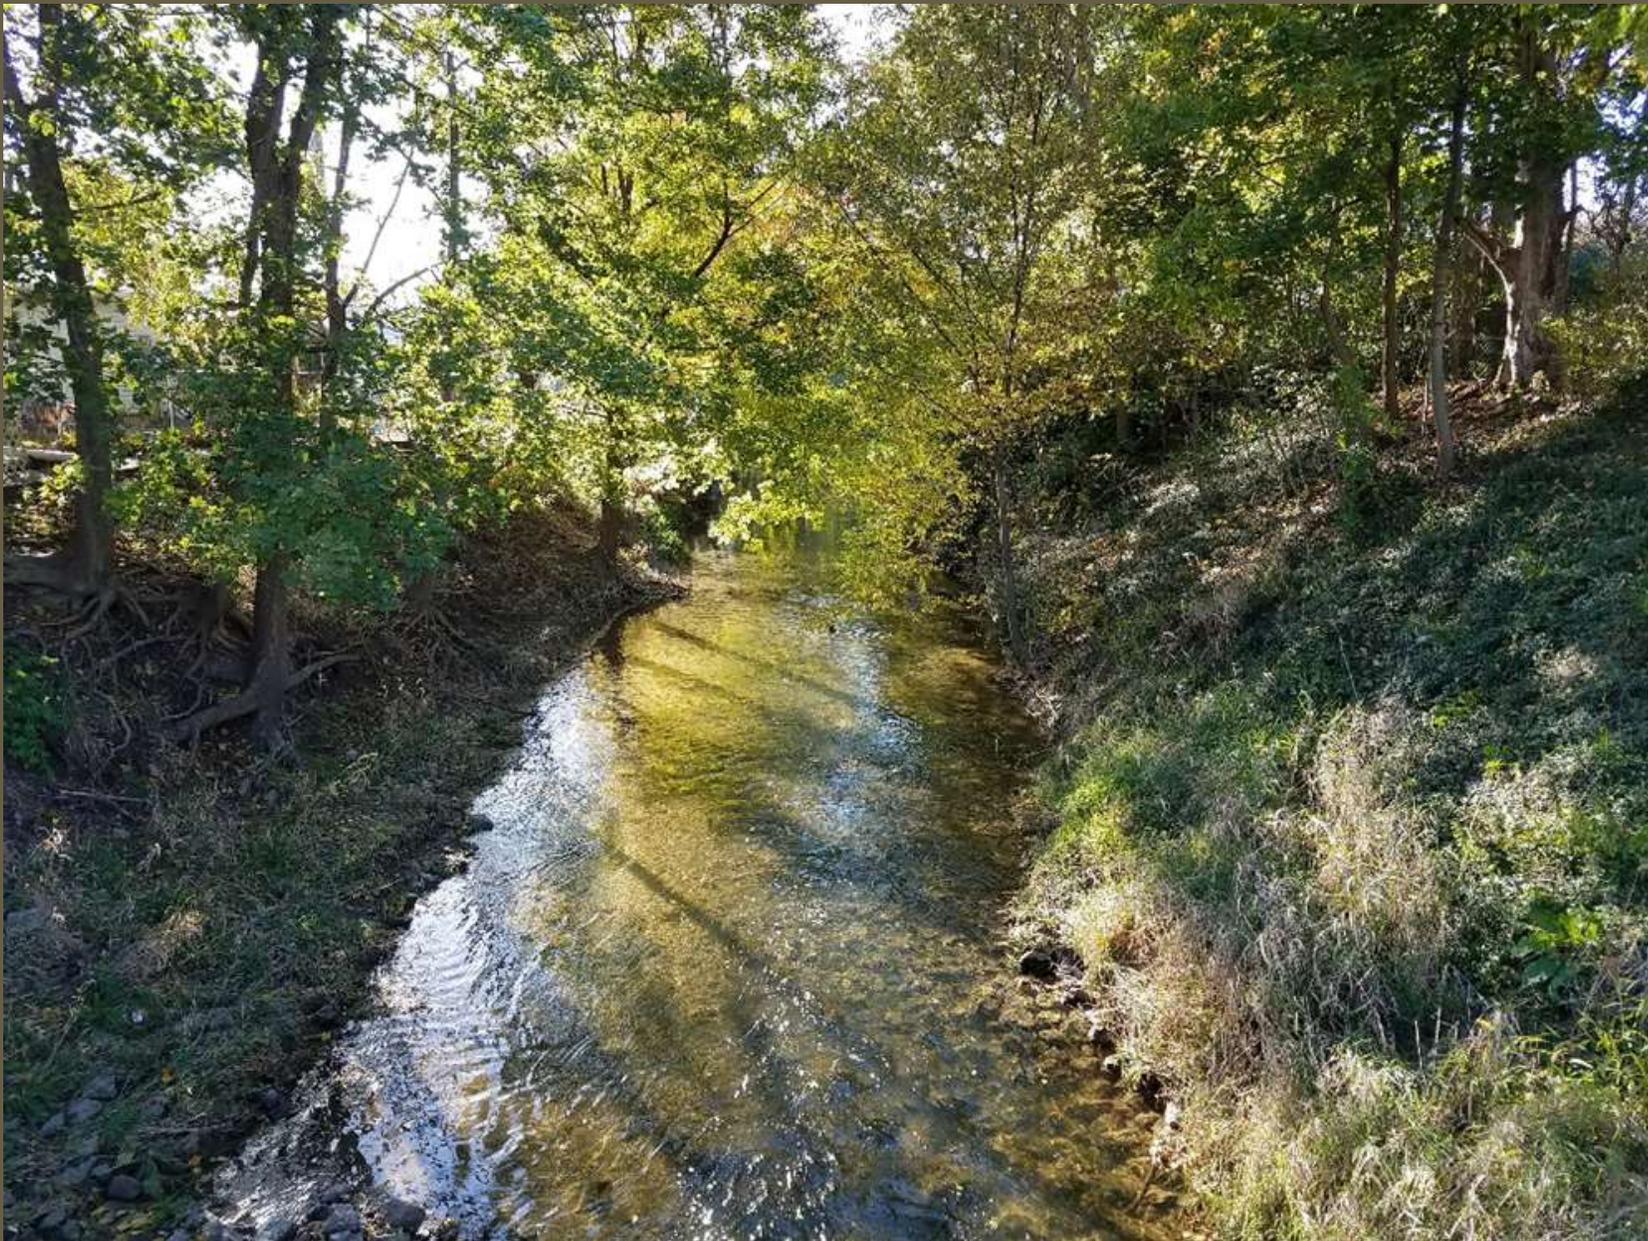
Looking downstream from the Meridian Street Bridge. Note height of banks, as in the upstream reach these banks are 9.5 to 10-feet above the channel bed.

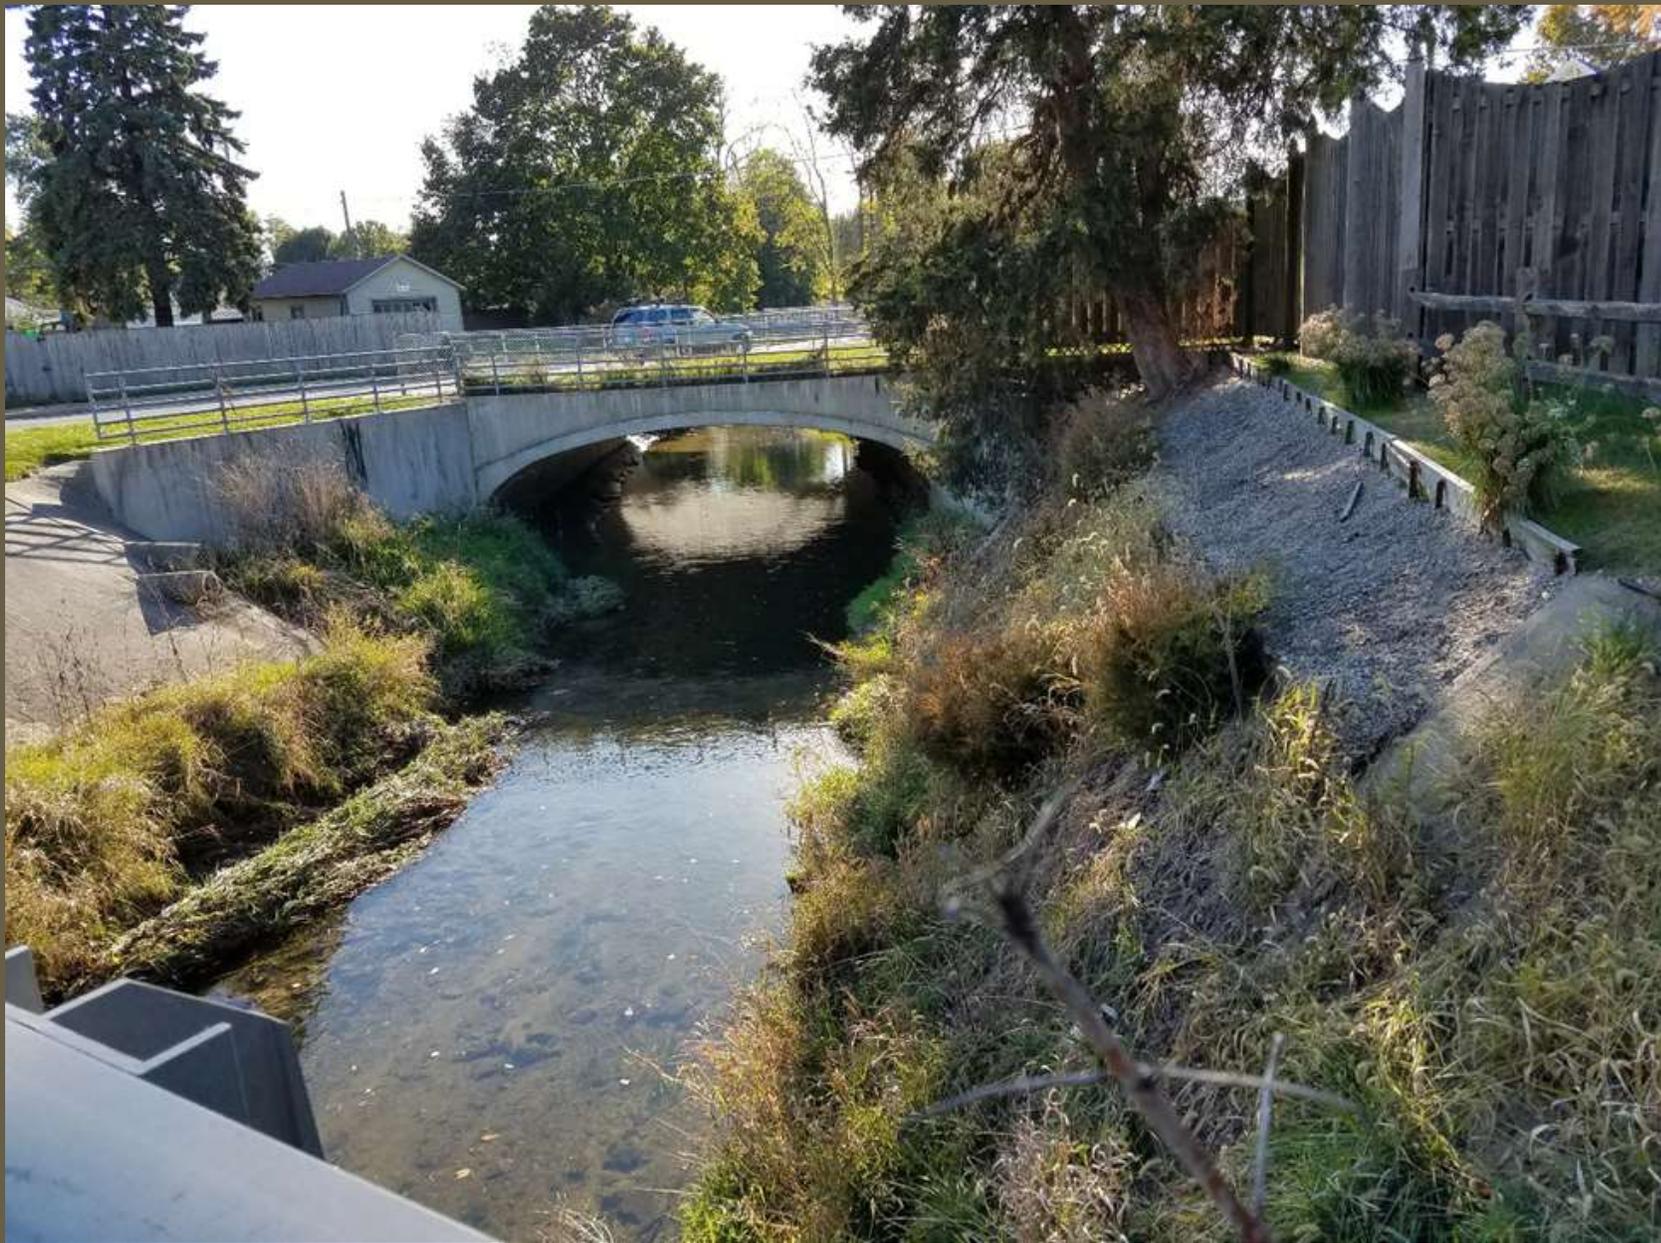
Looking downstream from the Lebanon Street Bridge. Left bank is poured concrete. Right bank shows several different efforts to stabilize the bank and proximity of home

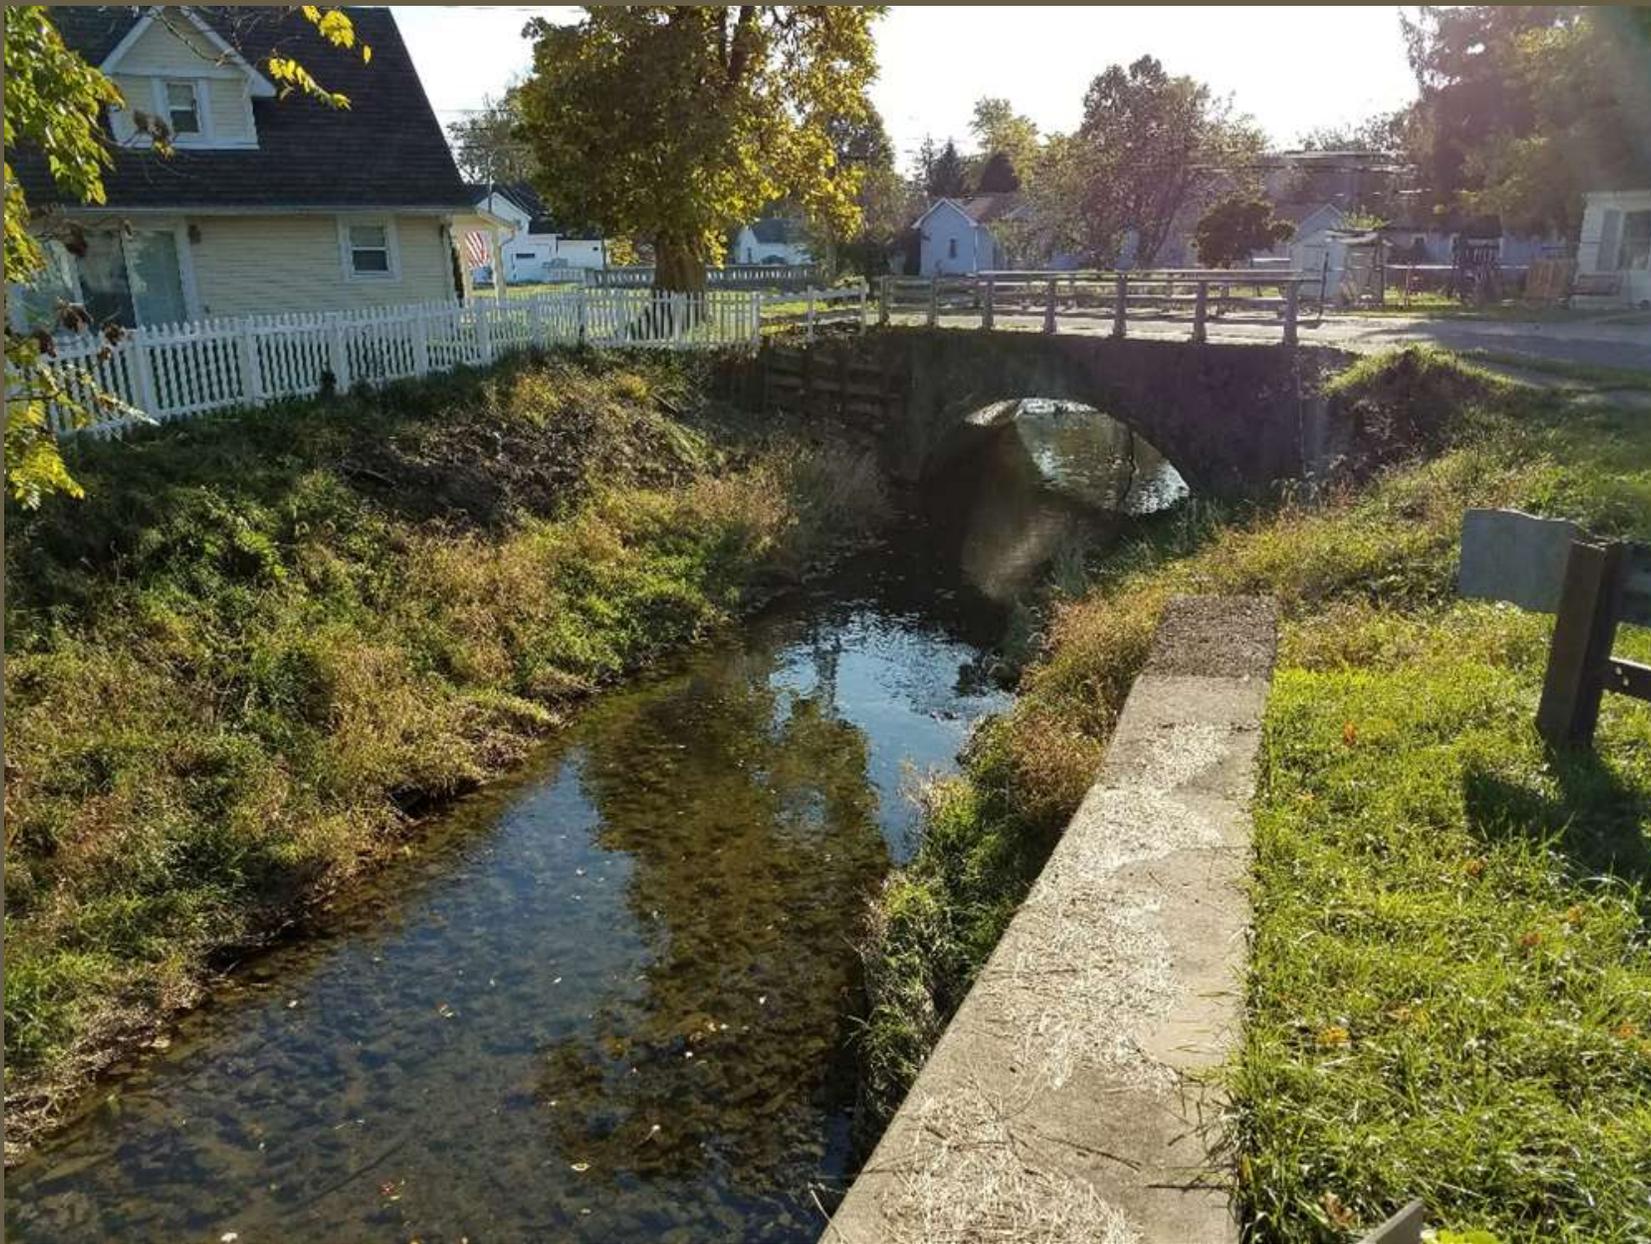
Looking downstream from Busby Street to Jameson. Reach is armored with concrete blocks, poured concrete walls, rubble, large blocks, and wood pallets.

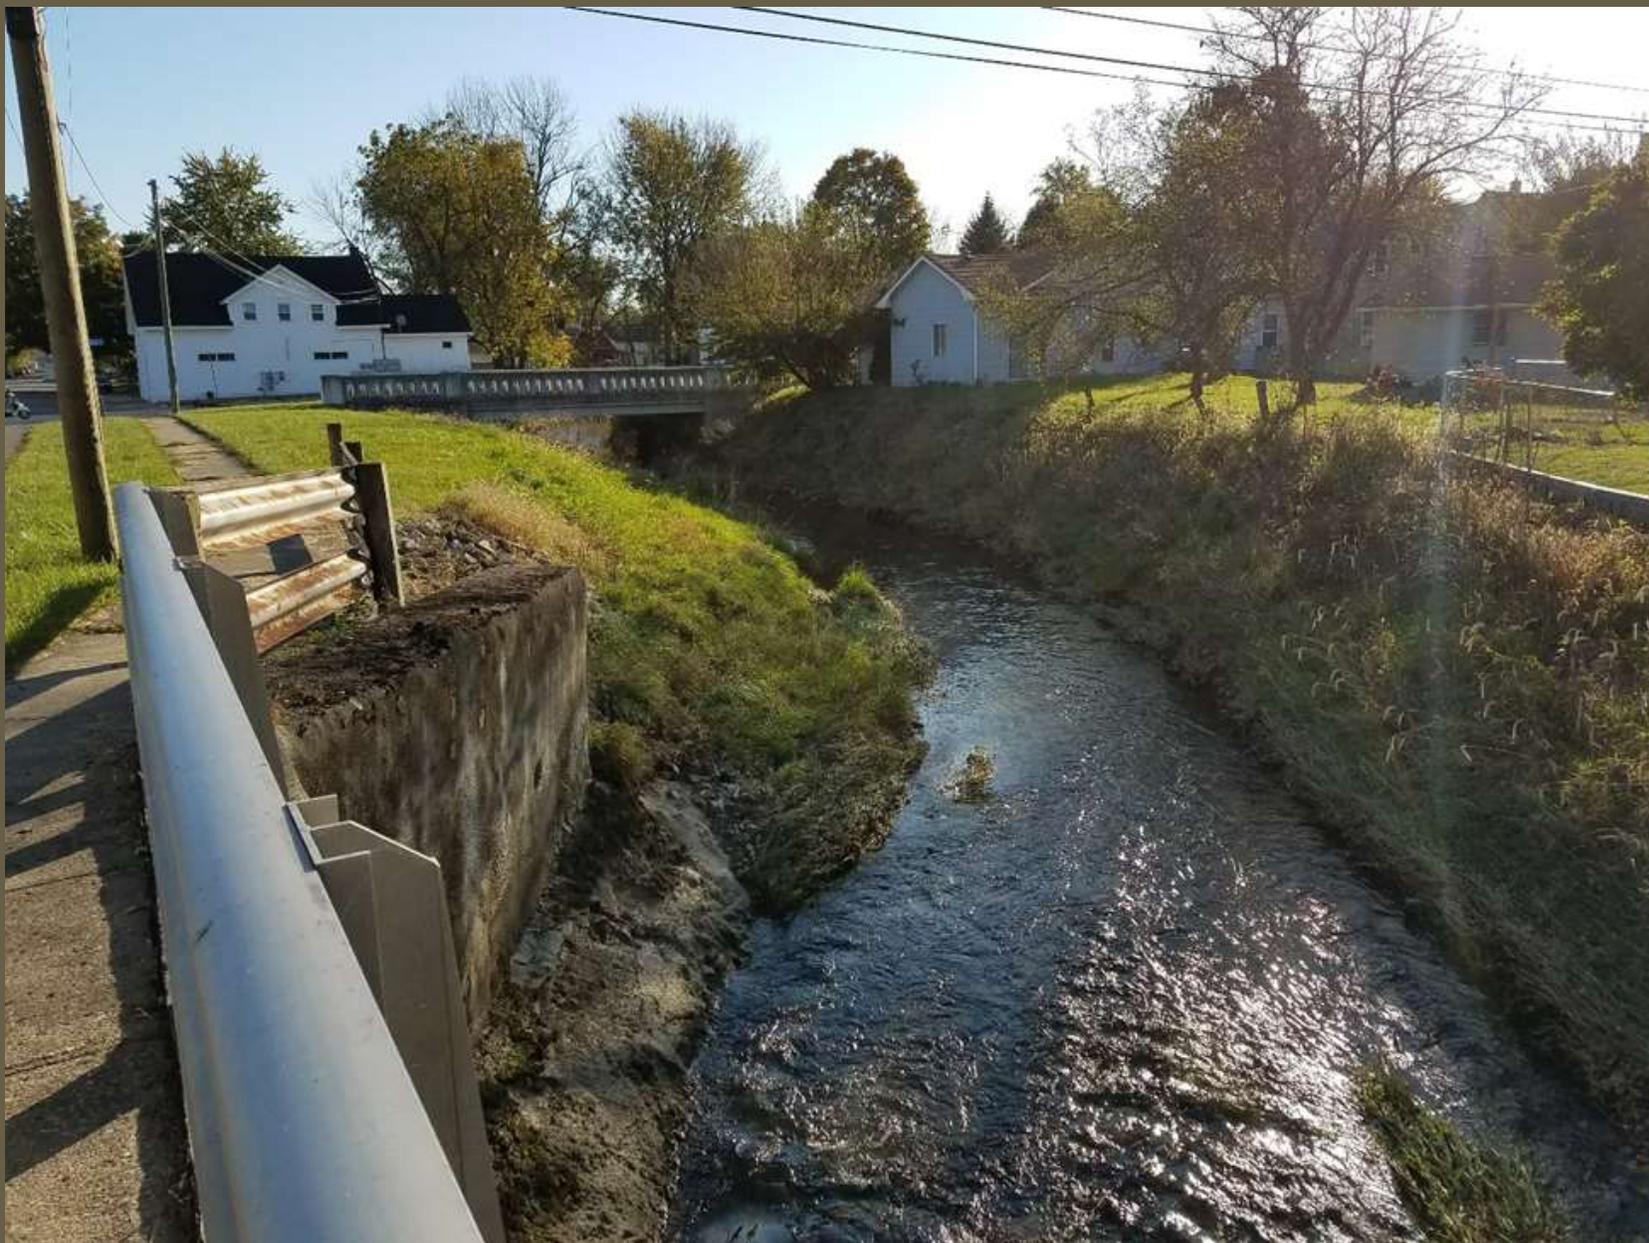
Looking downstream from Jameson Street to Chicago Street. Note the bridge deck on Chicago Street that seems to go halfway across the house. This reach is armored with old rip rap, gabions, and concrete walls.

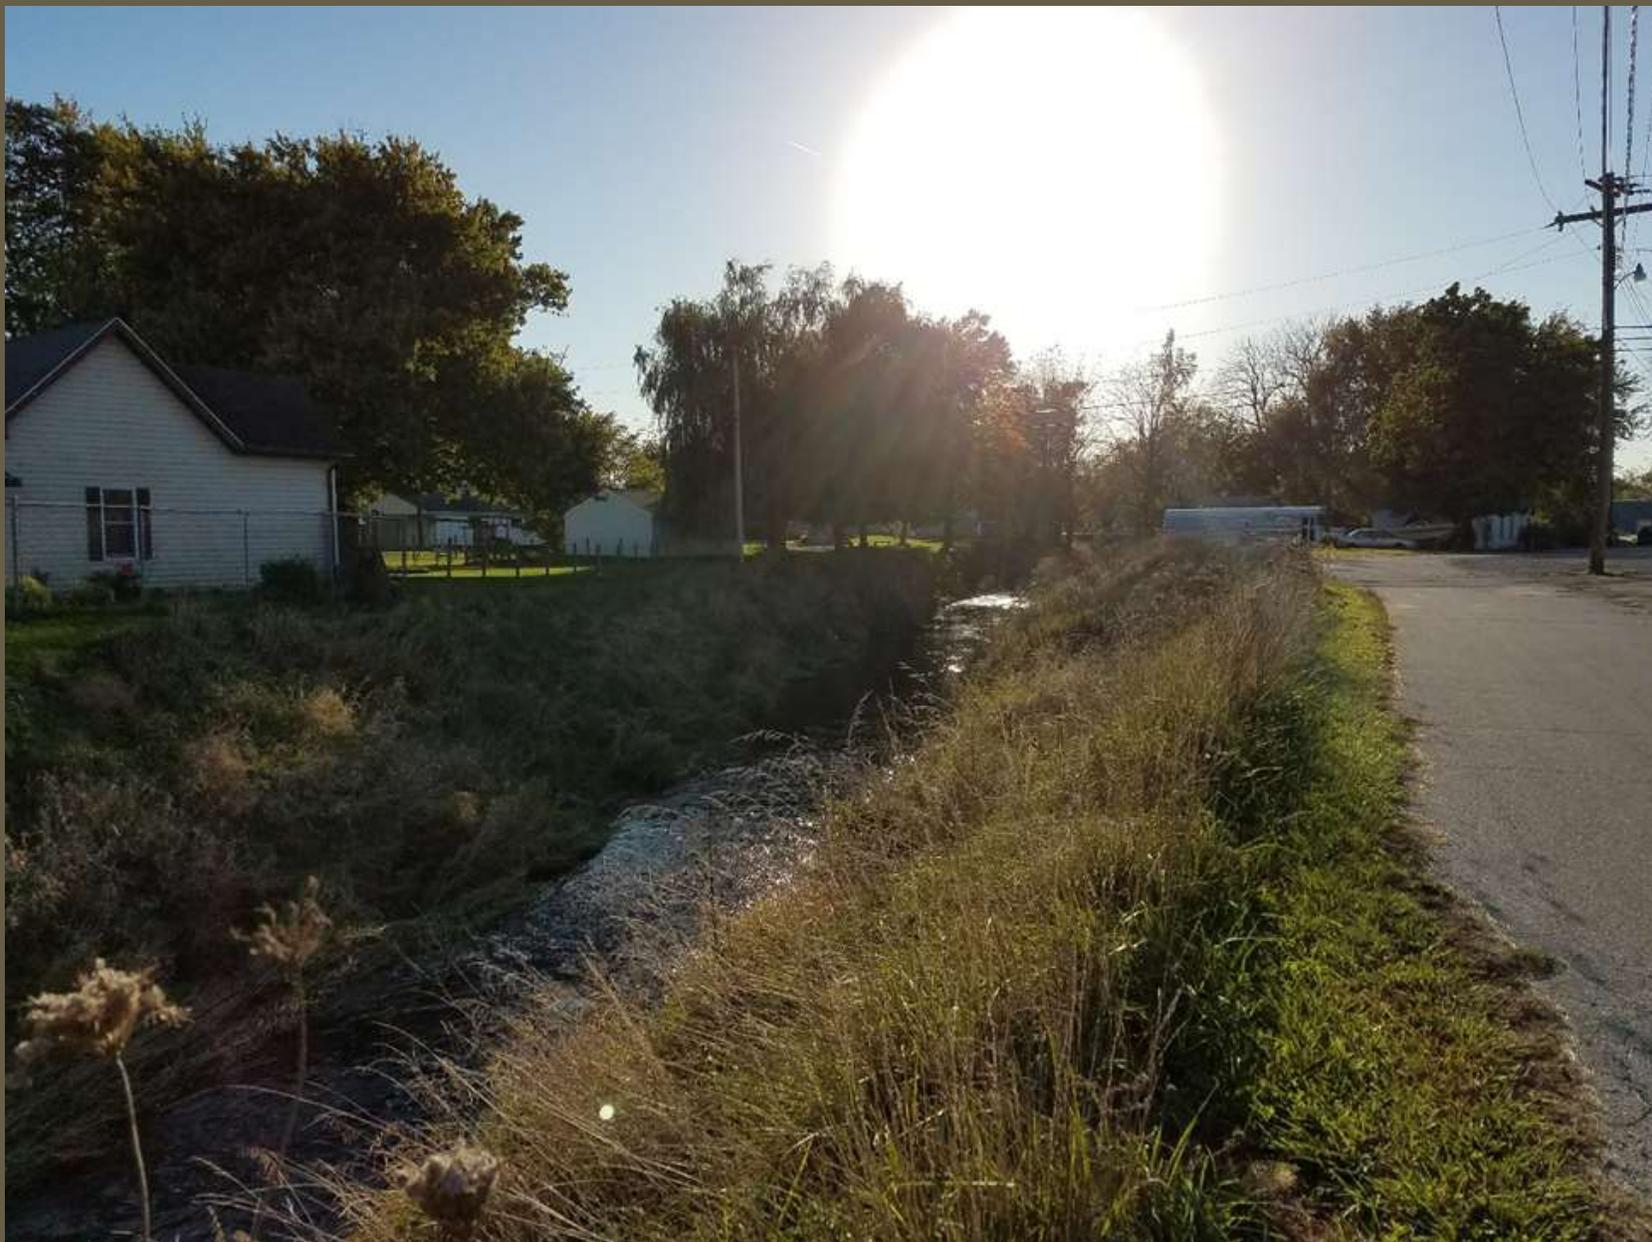
Looking downstream from Kersey Street to Lafayette Avenue. Notice proximity of road and homes to channel.

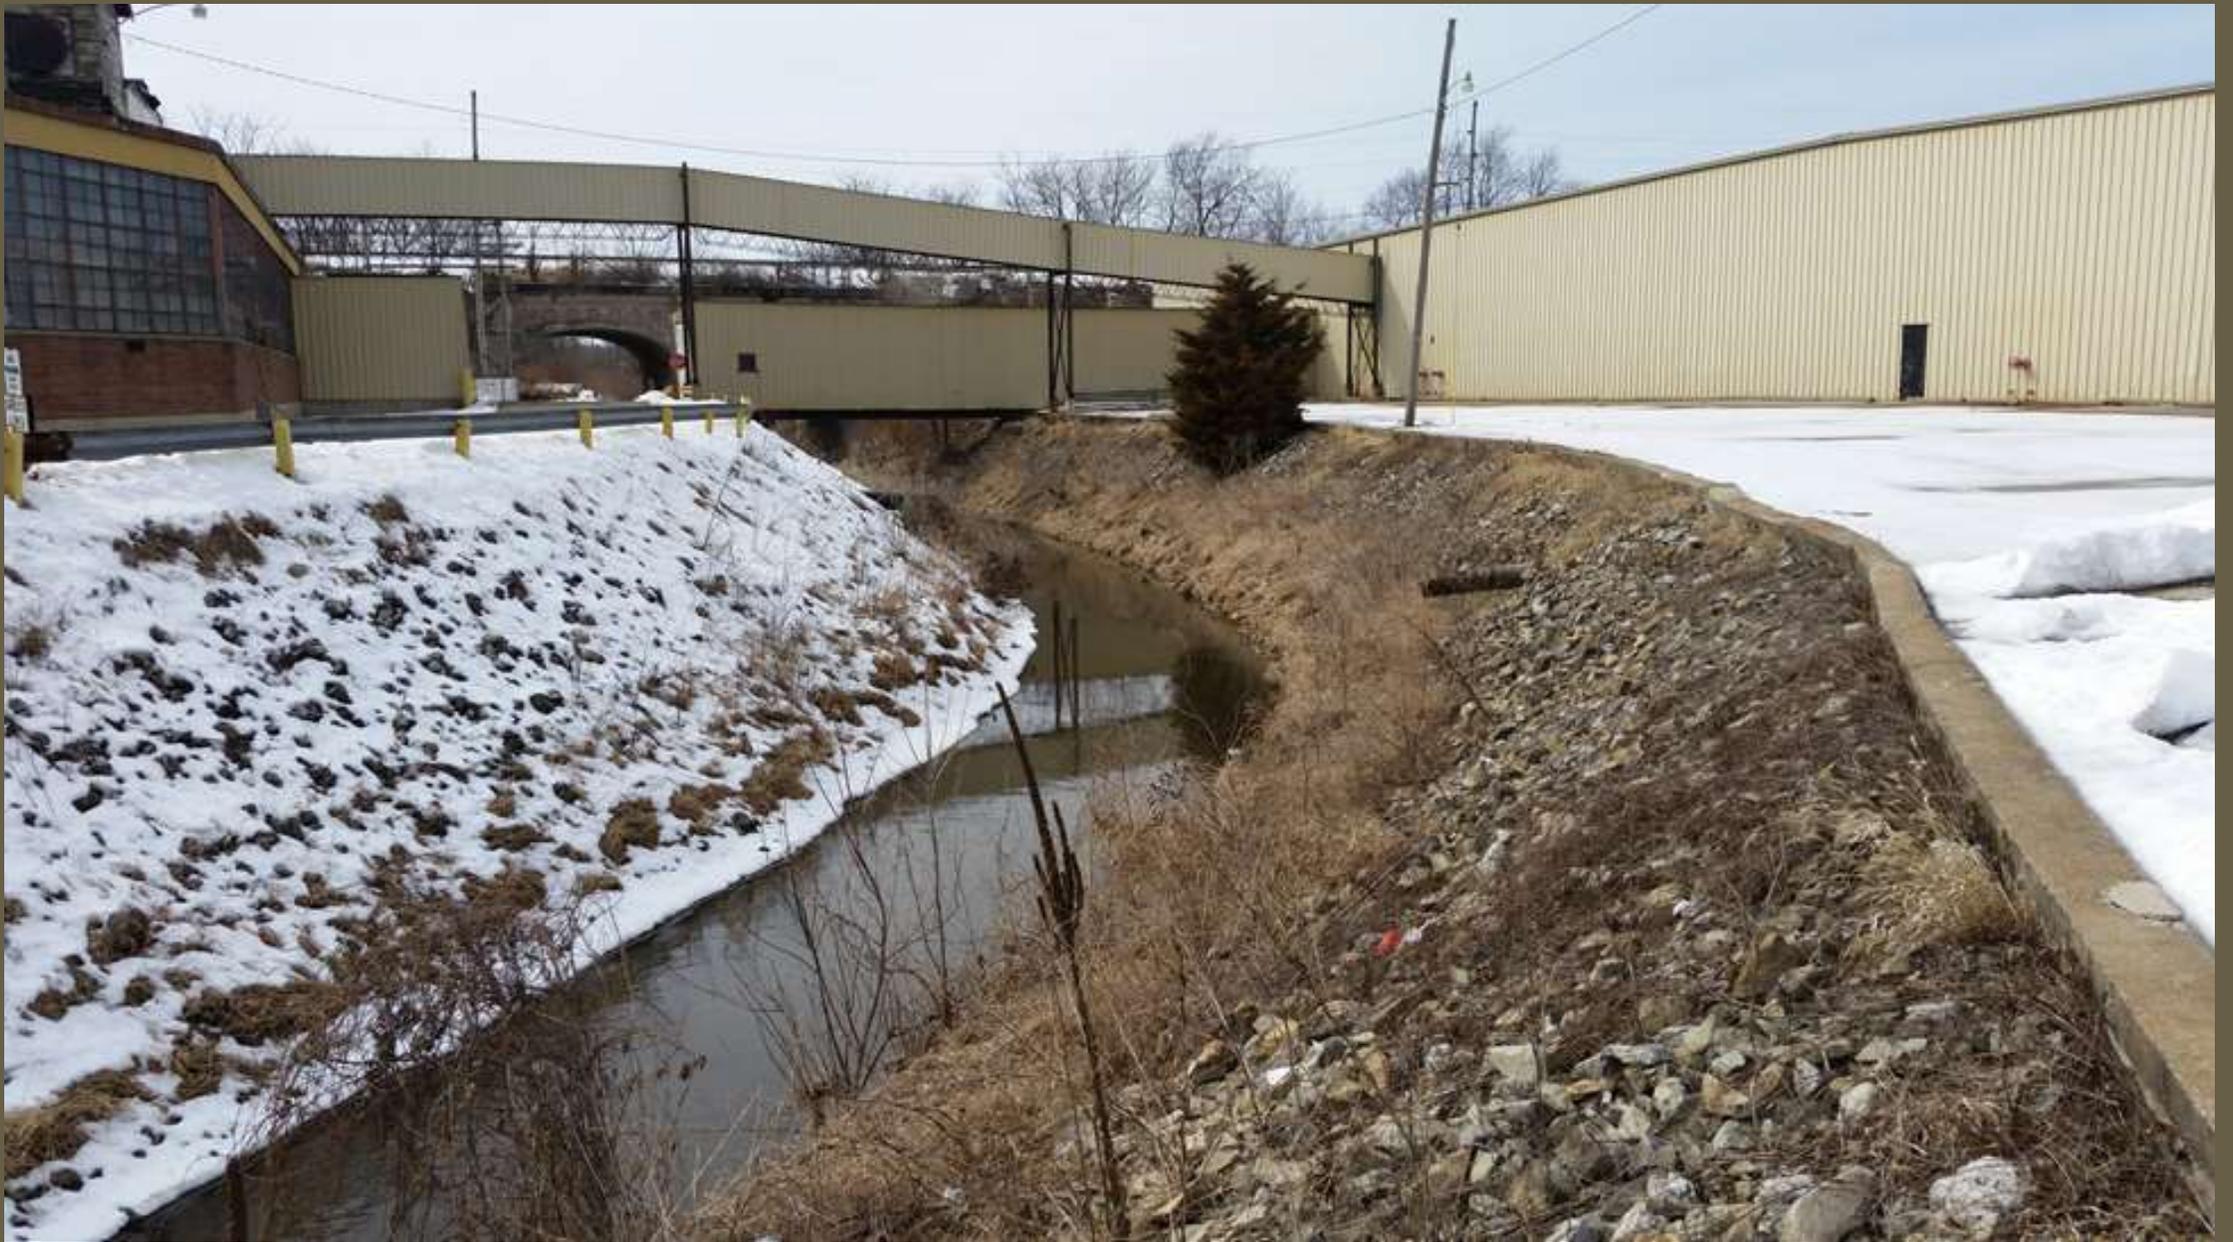
Looking downstream from the N. Patterson Street Bridge towards the RR Bridge. Parking lots on both sides of the channel come right to the top of bank. Notice that the box bridge in the background sits on the parking lot and would restrict any flood flows.

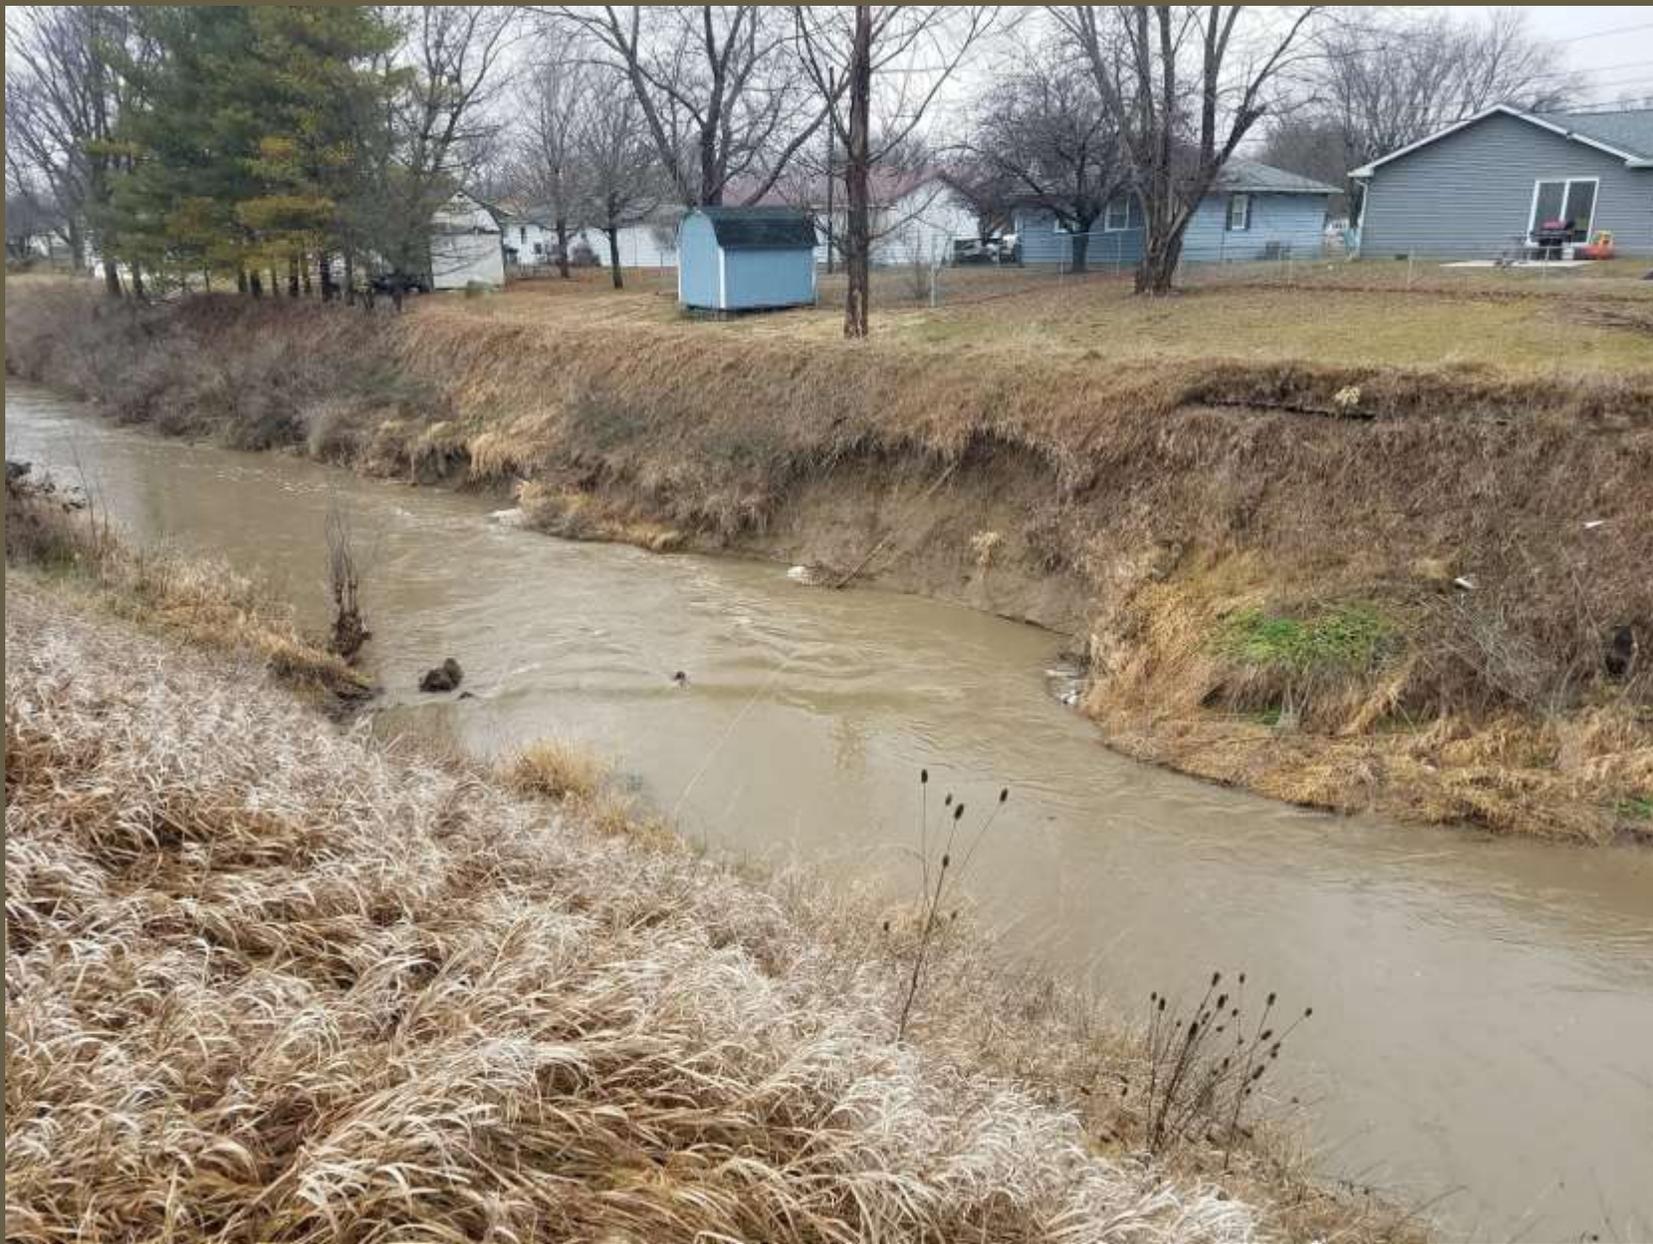
Downstream from RR Bridge, looking downstream from Farm Heritage Trail

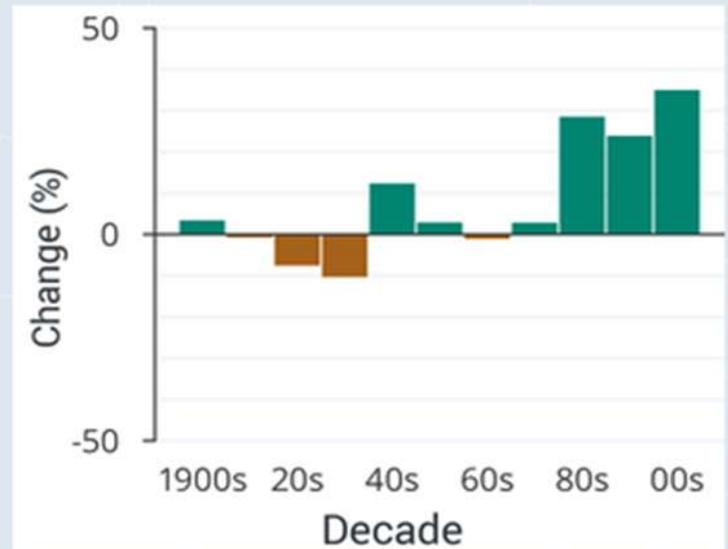
Percent changes in the annual amount of precipitation falling in very heavy events, defined as the heaviest 1% of all daily events from 1901 to 2012 for each region. (2014 National Climate Assessment)
