# A LITTLE ROOM FOR THE RIVER PLEASE !!!

## The case of Prairie Creek in Lebanon, Boone County, Indiana

INAFSM 2017 Annual Conference

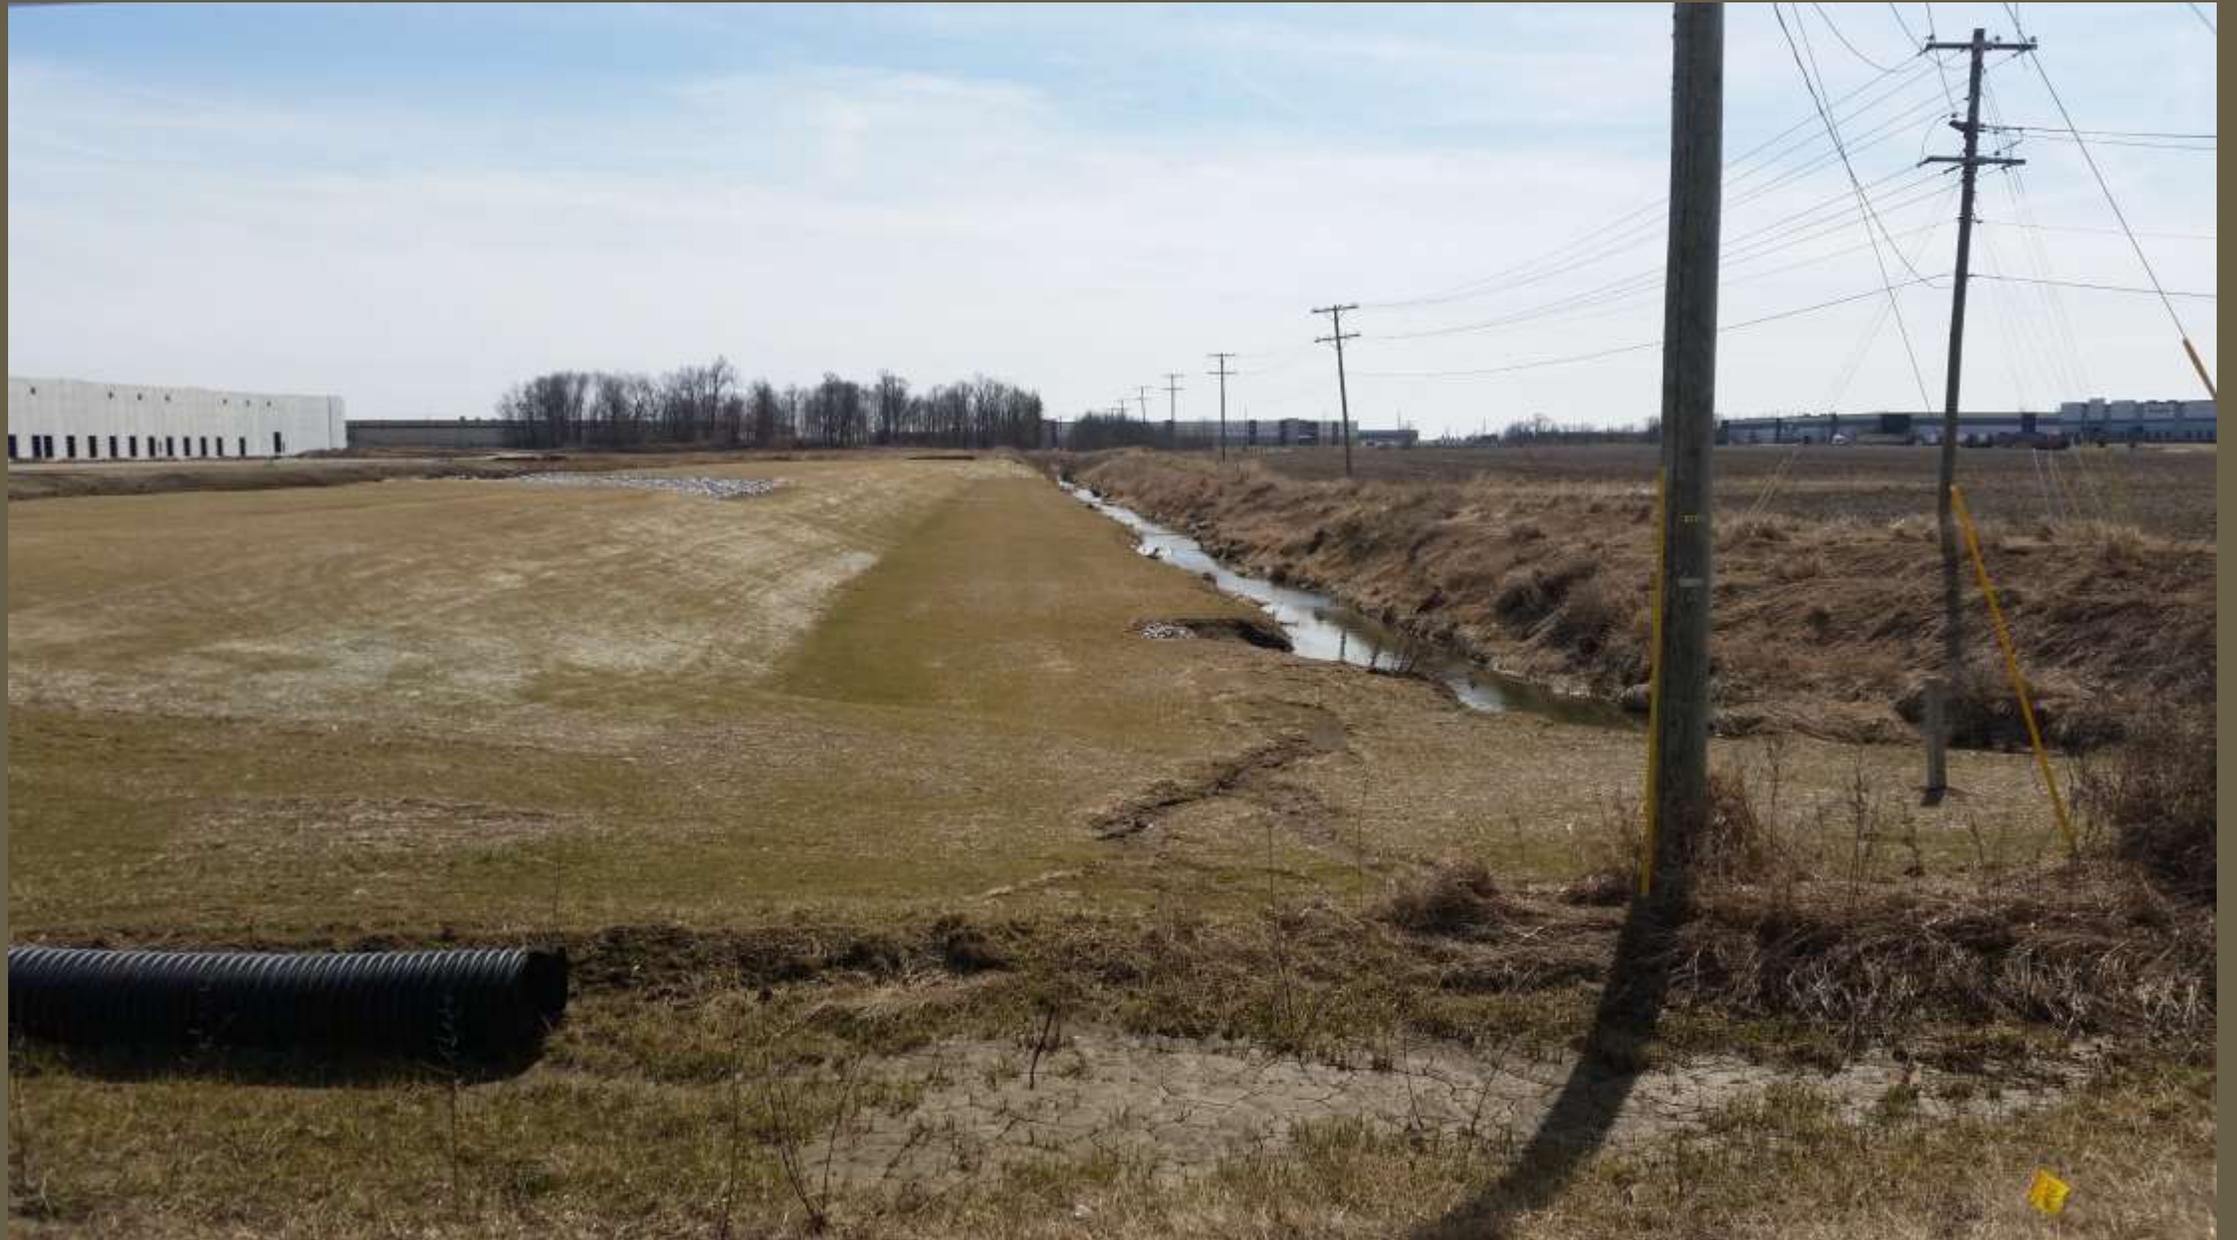
Sanitary Ditch at SR 32, looking downstream

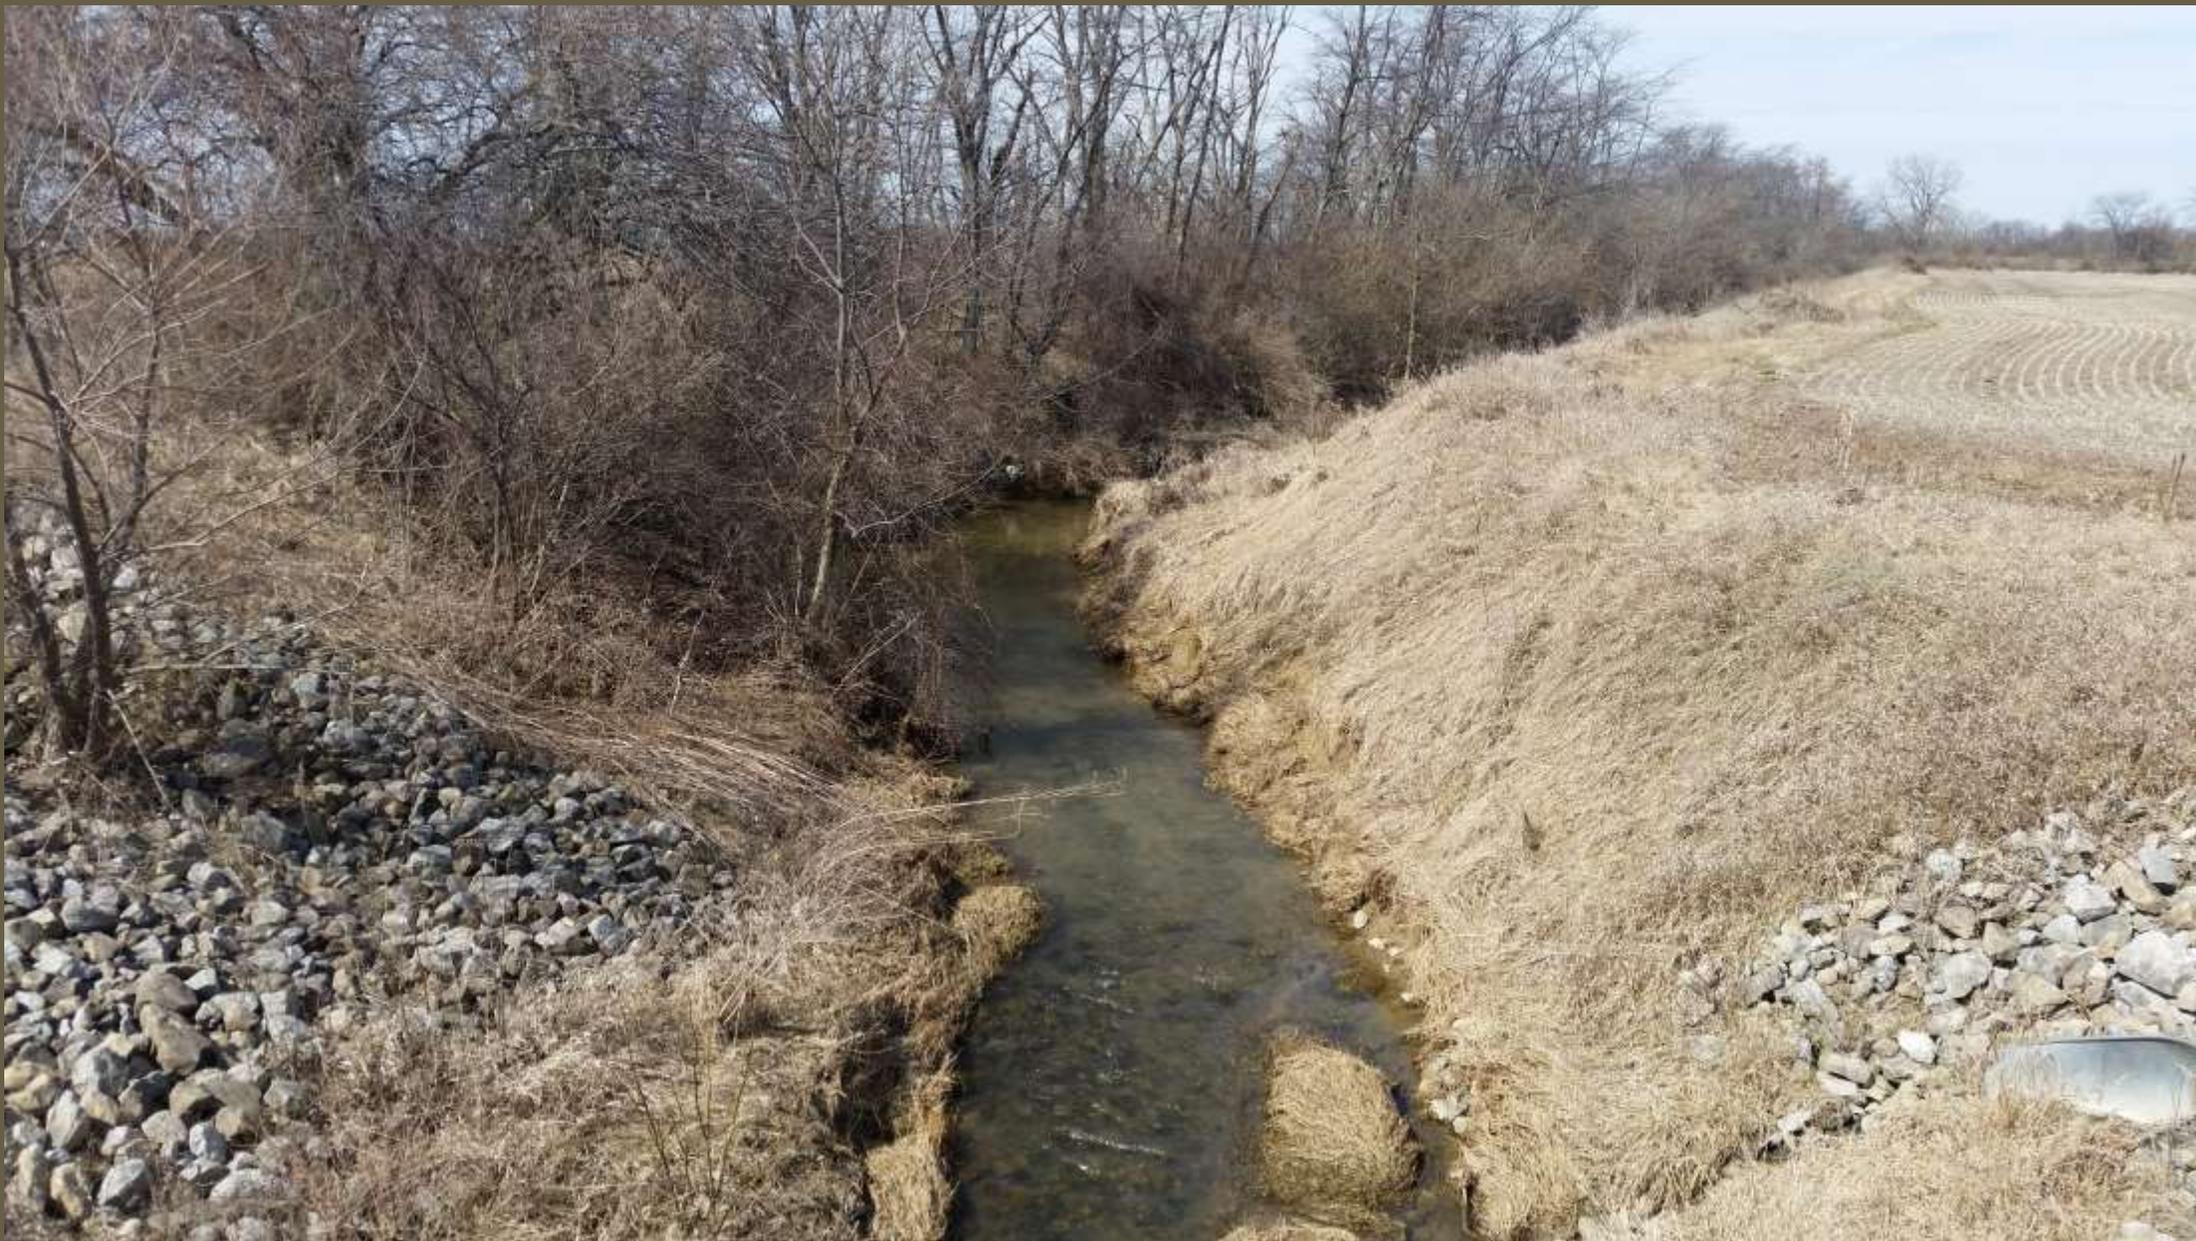
Sanitary Ditch at SR 32, looking upstream
